SAFETY ALERT

Safety Alert No. 348 25 April 2019 Contact: Nicholas Fraiche Phone: (504) 736-7631

Chemical Leak in Flying Lead Discovered by ROV

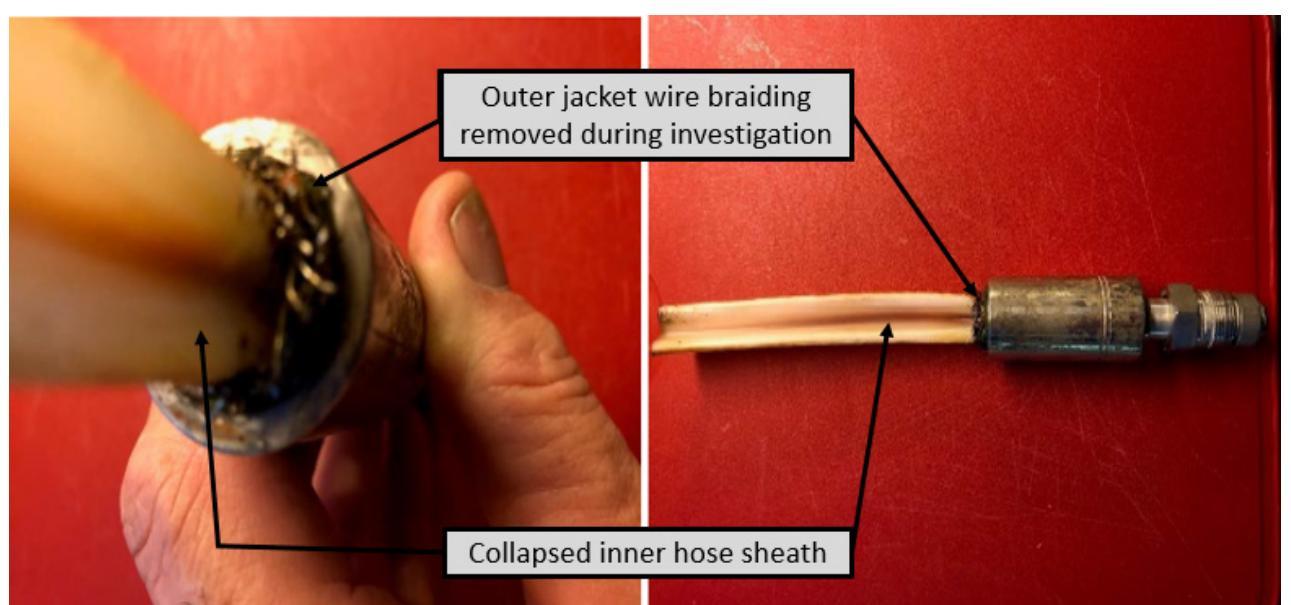
With the outer jacket wire braiding removed, the HFL hose inner sheath was revealed to be in a collapsed condition.

On April 30, 2018, BSEE received a report of a subsea umbilical leak coming from a Hydraulic Flying Lead (HFL) used for chemical injection. An ROV operator performing a survey for a future PLET installation discovered paraffin inhibitor (Nalco EC 6004A, which contains the chemical naphthalene) leaking into the Gulf of Mexico. It was later discovered that the chemical injection lines had sustained either breaches or breaks in two locations. The estimated maximum total volume of the discharge was 900 barrels.

The investigation revealed that the hose assembly was rated for the appropriate collapse pressure. The system had been installed in 2015 and tested to demonstrate full pressure integrity. At an unknown time after May 1, 2017 (the date of the most recent prior ROV inspection), the outer jacket of the chemical injection line sustained damage. Once the outer jacket was damaged, the line's collapse resistance was compromised. Positive pressure was not maintained in the chemical injection line, which resulted in a collapsed and torn line. The leaks were undetectable from the water's surface, either visibly or by detection instruments, due to the water depth in which the facility is located.

Therefore, BSEE recommends that operators consider the following:

- Update operating procedures to ensure that umbilical lines are positively pressured.
- Provide operator training to ensure that lines are not bled to a zero pressure during maintenance tasks.

- Install a check valve to the system topsides to ensure a positive pressure is maintained on the system.
- Install a low-pressure alarm on the chemical pump skid for any injection lines that are connected subsea with a hose.

- Monitor fluid inventories of fluids that are pumped subsea.
- Consider subsea hose assembly movement (such as chafing, rubbing, friction, etc.) during design.

- Inspect subsea equipment on a regular basis utilizing ROV visual video recordings. The visual subsea equipment inspections include inspections of umbilical lines, subsea wellheads, subsea manifolds, etc. The regular visual inspections should identify initial issues with the subsea installation, as well as later life issues which occur during production operations.
