SAFETY ALERT

Safety Alert No. 410 February 8, 2021 Contact: Tony Richardson Phone: (571)-353-4122

Damaged Electric Cord Results in Arc Flash

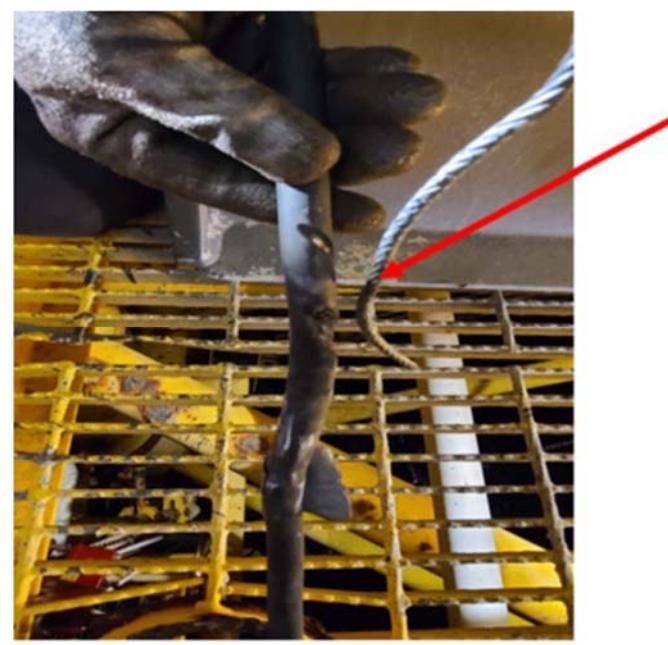
Upon immediate investigation, it was discovered that the rubber protective coating on the electrical welding lead cable was worn down by the continuous movement of steel SRL cable rubbing against it, which resulted in exposed welding lead cable wires. When the welding machine was turned on, the steel cable on the SRL made metal-to-metal contact with the welding lead cable wires and triggered the arc flash. This caused damage to both the welding lead cable and SRL cable.

A frayed SRL cable that made contact with metal grading.

The SRL cable rubbed and wore down the outer coating of the welding lead when the cable moved up and down through a deck penetration hole.

When the welding machine was turned on, the exposed lead arced on the SRL cable and broke the cable at the arc point.

- Confirm proper separation of electrical energy sources, such as electrical cords and welding leads, from rigging, fall arrest equipment or any other identified equipment on a work site that could cause physical damage;

- Ensure that welding leads and SRL cables are separated during hot work activities and avoid putting them through the same deck penetration plate;
- Inspect welding leads and SRL cable before use to ensure they are in good working condition;

- Ensure safe routing of electrical equipment cords, cables, etc., to prevent abrasion and abnormal wear of their protective sheathes/coatings;
- Before work begins, check the final worksite to ensure all safety provisions/systems are in place and all hazards are controlled and risks are reduced to as low as reasonably possible; and,
