Integrity Management Process of Tension Leg Platforms

Final Report

BSEE Project Number: E17PC00018

Prepared by:
Energo Engineering
601 Jefferson Street
Houston, Texas 77002

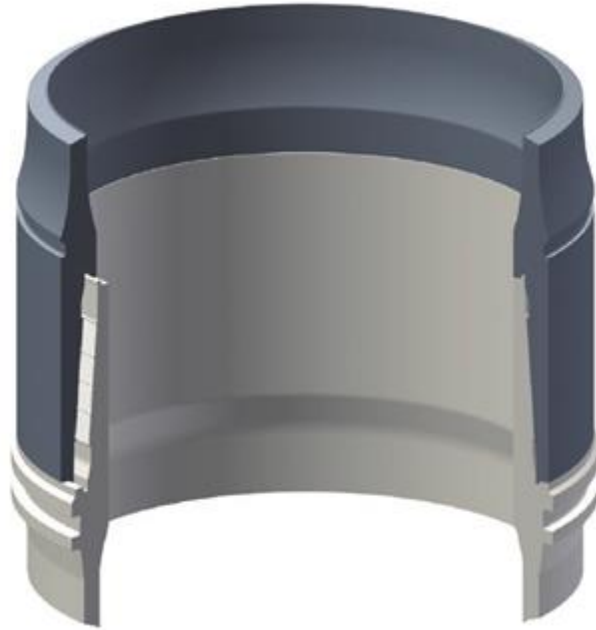
Figure 2.4 - Merlin Tendon Coupling (© Oil States Industries, Inc.)

The earliest TLP’s used screw thread couplings or single piece continuously welded tendons, but starting with Auger in 1994, all GOM TLP’s have used a tapered, non-helical, grooved thread coupling derived from a casing connector which cannot come un-screwed. This was first developed by Oil States Industries (OSI) for Shell Oil and known as the Merlin Coupling (see Figure 2.4), but has since been further developed by others (GMC - Intermediate Tendon Connector - ITC). The pin and box, when first initially assembled, are limited to not engaging the last thread due to the taper of each, and the interference of the threads. A preliminary metal-to-metal seal at the root and tip of the pin section allows the introduction of high-pressure hydraulic fluid into the threaded region, which squeezes the pin and stretches the box, allowing the connector pair to be forced together to its final engagement position. Relaxing the hydraulic pressure allows full engagement of the threads, which form a strong, non-rotating bond. Ideally, the connector is reversible, but disassembly has not been attempted on any tendons after years in place. The big concern in removal is the ability of the seals to hold hydraulic pressure after years of exposure to seawater.

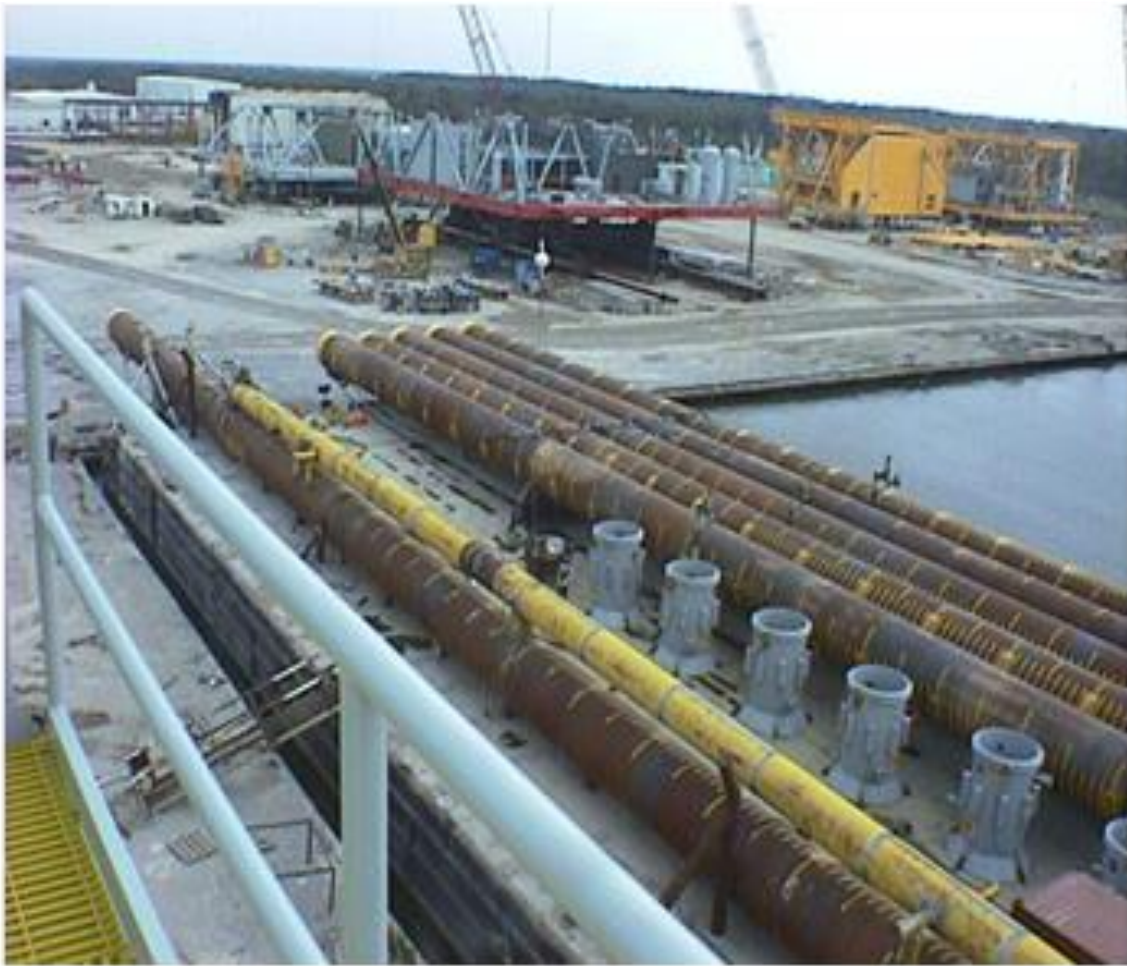
Figure 2.6 - Piles with receptacles attached. The CP anode sleeves shown are installed after pile driving. (Photo courtesy of ENI)

The driven foundation piles for GOM TLP’s are typically 72” – 96” diameter, and are 300 to 430 ft. long. The receptacles are generally 60-72” diameter, and are configured for the roto-latch or snap ring connector styles (see Figure 2.6). If the pile and receptacle are differing diameters, a tapered transition is used between them. Because of the stresses during pile driving, and because they are not easily inspectable, the piles and receptacles are generally designed to operate at much lower stresses than the tendon itself, and have very long fatigue lives.

The anodes at the pile are typically mounted on a sleeve around the top of the pile or on a sled beside the pile in order to avoid damage to anodes during pile driving. In all cases, since the flex joints are an electrical isolating element, there is a jumper cable top and bottom to connect the tendon to the pile and to the hull.

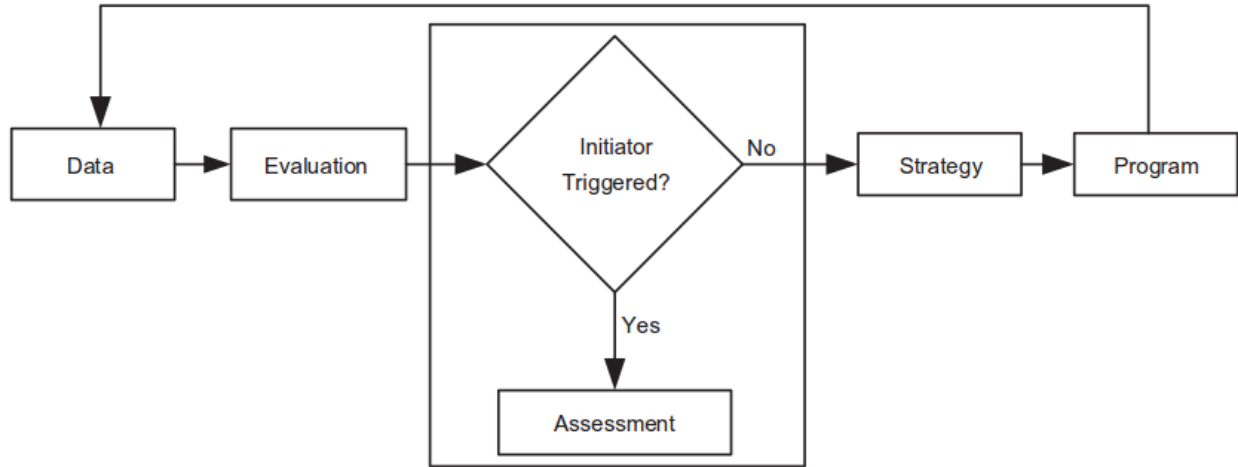
Figure 6.1 - SIM Process (Ref. 3)

The recommended methodology is structured around the Structural Integrity Management (SIM) process shown in Figure 6.1. Organizing the tendon methodology in this manner ensures the approach will align with the existing API and ISO SIM processes, and the future API RPs (i.e., 2FSIM, 2RIM and 2MIM). These current and future documents provide the high-level integrity management framework while this recommended tendon integrity methodology describes specific considerations and detail for tendon systems.

The purpose of the SIM process is to provide a proactive process for demonstrating the system integrity throughout its life on a fitness-for-service basis. The SIM process relies on collecting data on the system, periodically evaluating the data and using the evaluation to set a strategy that, when executed, will gather additional information on the tendon's condition that can be used to confirm fitness-for-service. Throughout the service life of the TLP, new data are collected through monitoring activities, scheduled maintenance, scheduled and unscheduled surveys, or planned changes (e.g., modifications or additions) to the TLP. As new data are obtained, the data is subject to engineering evaluation to confirm fitness-for-service. Based on the evaluation, adjustments to the strategy plans and program work scopes can be required to confirm fitness-for-service and maintain the system's integrity.

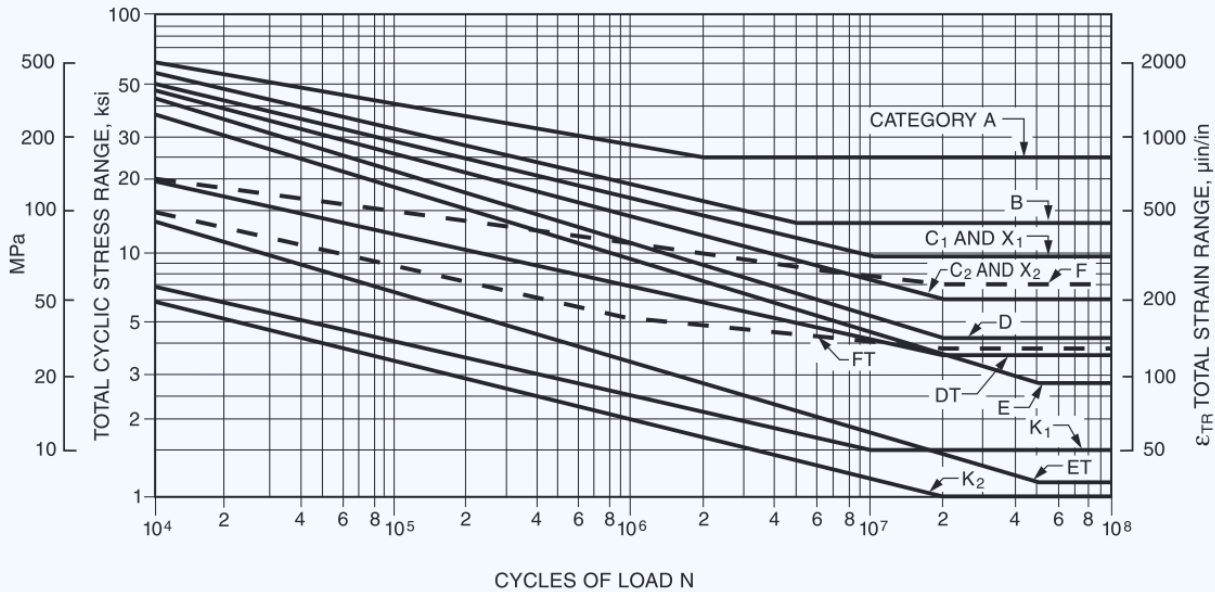
Figure 8.5 - AWS D1.1 Design S-N Curves - Tubular Structures for Atmospheric Service (Ref. 13)

As shown Figure 8.4 to Figure 8.6, the slope of the design S-N curves may change after an endurance limit (usually between 10^6 and 10^8 cycles) is reached. However, in reliability assessments, a single slope may be used for easier implementation. If a single slope approach is to be used the selection of which slope should be based on the distribution of stress range bins. It is conservative to use the slope and intercept (mean and standard deviation) of the first segment (left side). If most of the stress range bins fall in the second segment of the S-N curve, the second slope and intercept should be used. If the stress range bins spread between the two S-N curve segments, a two slope S-N fatigue reliability analysis can be implemented (Section 8.5.5).

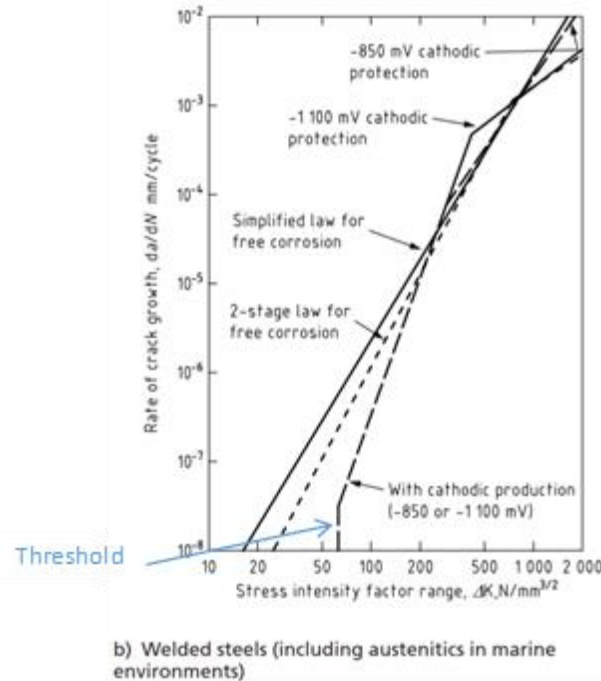
Figure 8.9 - Example Crack Growth Parameters (BS 7910)

The crack propagation, or growth, under cyclic loading is usually assessed based on Paris' law (Equation 8.3). Figure 8.9 shows example crack growth parameters that may be used in the tendon fracture mechanics design assessments. Similar to the S-N curves, the design crack growth parameter A is usually 2 standard deviations above the mean A of the test data. Therefore, it may be too conservative to use the design crack growth parameters directly in the reliability assessment, and using the mean parameters along with the standard deviations would be more appropriate. If project-specific crack growth parameters (mean and standard deviation) are not available, parameters such as those shown in Figure 8.10 and Table 8.4 can be used for the fracture mechanics based reliability assessment. Design crack growth parameters are also presented in the figure and table for comparison.

Design crack growth parameters often represent a 2-stage crack propagation (e.g., dash lines in Figure 8.9). For tendon design assessments, the threshold behavior is often conservatively ignored. The crack growth process is usually further simplified in reliability analysis by using 1-stage crack growth parameters. The parameters can be the 1-stage parameters appropriate for reliability analysis or first stage of the 2-stage parameters. The framework and examples demonstrated herein are based on the 1-stage crack growth assumption.
