Safety Alert No. 498

Explosion and Fire on Liftboat Injure Workers – BSEE Calls for Enhanced Safety Measures and Emergency Preparedness

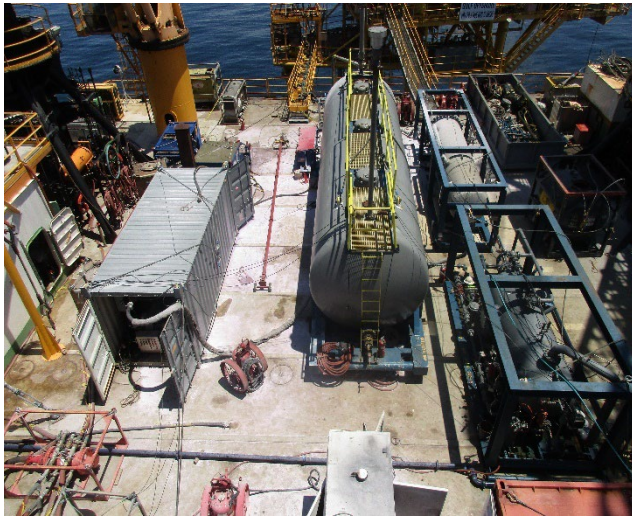
Figure 1. Test separator and 500-barrel tank.

The explosion was caused by a gas accumulation on the liftboat deck during the draining of fluids from a test separator into a 500-barrel tank (Figure 1). The night supervisor initiated the draining process, and five minutes later, a surge in the generator engine (Figure 2) triggered the explosion and multiple fires. Two contract workers were injured, suffering burns to their faces, necks, and hands. The liftboat's fire suppression system extinguished the fire within 15 minutes.

- No formal procedures existed for draining fluids from separators or preparing the 500-barrel tank for testing.
- Workers relied on hydrogen sulfide (H₂S)-specific gas detectors, which could not detect explosive gas mixtures.
- The generator's air intake shutoff valve control module failed to function, allowing gas infiltration.
- Improperly latched hatches on the tank allowed gas to escape.
- Night shift safety meetings lacked oversight by company representatives, reducing communication effectiveness.
- Workers reported holding level controllers open until gas blow-by was detected, increasing risk to personnel safety and operations.
- Loose hatch bolts on the tank, caused during transport, were not adequately inspected upon arrival.

- Establish comprehensive written procedures for all critical operations, including draining fluids from separators and preparing tanks for well tests. Regularly review and update standard operating and safety procedures to align with industry best practices.

- Conduct a thorough inspection of vessel hatches to ensure a proper seal.
- Conduct thorough inspections of tanks, generators, and flame arrestors before and after transport to ensure proper function and secure fittings.
