Safety Alert No. 500

Dropped Steel Plate Due to Defective Lifting Device and Inadequate Hazard Analysis

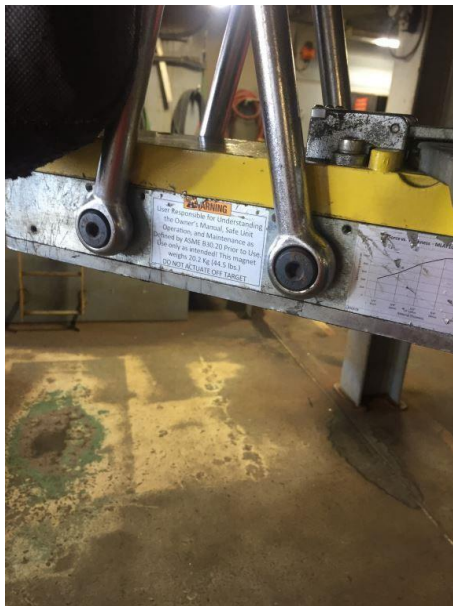
Figure 1: A magnetic lifting device.

The investigation revealed that the magnetic lifting device was ineffective due to wear and tear. Manufacturer tests indicated that wear damage to the lifting device could create air gaps, preventing it from functioning effectively. Additionally, the job safety analysis (JSA) conducted before the operation did not adequately address the specific

- Implement a robust inspection program for lifting devices to ensure they are maintained in safe working condition and regularly evaluated for wear and tear.

- Establish a reporting mechanism for any observed defects or safety concerns related to lifting equipment.
- Operators should know that even brief power spikes can disable electromagnets, leading to dropped loads. To prevent sudden loss of magnetization, implement procedures to monitor power stability and ensure that backup systems are in

- Set guidelines to prevent coils from burning out by limiting how long operators power on electromagnets. Train operators to turn off the magnets when they are not in use, especially if the magnets are not designed for continuous duty cycles..
- Look into the implementing industry-standard pre-use inspection and load testing procedures for magnetic lifting devices. ASME B.30.20-3 provides guidelines for marking, construction, operation, and specific pre-use protocols, such as thorough inspections to ensure that the lifting surface is clean and free from debris, oil, paint, or rust, which can interfere with the magnet's contact and reduce lifting capacity. Visual inspections should be supplemented with functional tests to verify lifting capabilities.
- Encourage open communication among crew members regarding safety practices and adhering to established protocols.

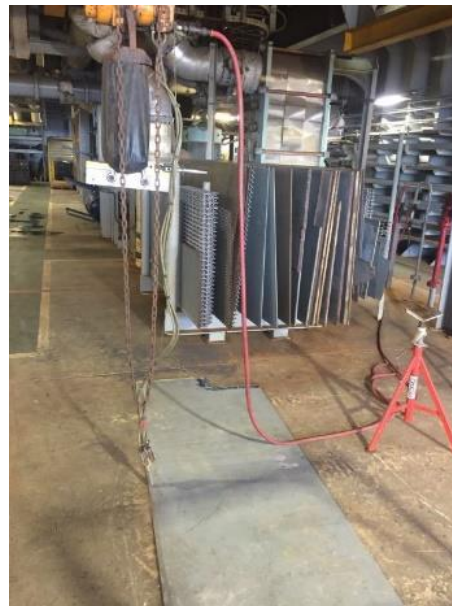
Figure 2: Steel sheet and incident area.

The Bureau of Safety and Environmental Enforcement (BSEE) recently investigated an incident involving a dropped steel plate during drilling operations, which injured two personnel. The incident occurred while transferring a partial 3/8-inch steel plate sheet using a magnetic lifting device. During the lift, the steel plate unexpectedly detached from the magnet and fell approximately 47 inches, landing on top of both individuals' left feet. Both personnel reported bruising and swelling and were evacuated for medical evaluation.

- Revise job plans to ensure that the team adequately addresses specific hazards associated with lifting gear and suspended loads..
- Conduct thorough JSAs that include a comprehensive hazard assessment for all lifting operations.

- Foster a culture of safety that encourages personnel to stop work and discuss potential hazards whenever uncertainties arise.
- Train all personnel on the proper use of lifting equipment and the importance of confirming that all safety mechanisms are engaged before lifting operations commence.
