SAFETY BULLETIN

Safety Bulletin No. 003
March 8, 2017

Mud/Gas Separator Cleaning Results in Death

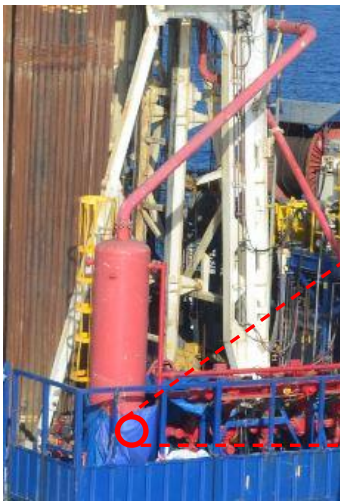
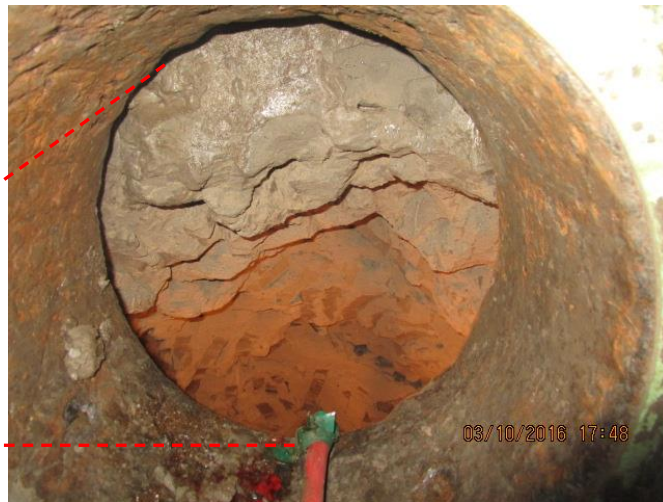
A fatal incident occurred when an Assistant Driller (AD) placed his head and an arm into a platform drilling rig's vertical Mud/Gas Separator (MGS) through its inspection hatch, while performing the assigned, but non-routine task of removing built up and hardened material from inside the MGS.

A BSEE Panel investigation identified a number of established Safe Work Practices (SWPs) that, if followed, should have prevented the task from proceeding in the manner in which it occurred. The contaminating material, believed to be cement, had already begun to cure and harden inside the MGS when it was discovered. The decision was made to attempt to remove the material, and supervisors authorized the task without understanding of the extent of the buildup.

the overhead material from falling. Despite some of the workers having expressed individual concerns about the task conditions, stop work authority was not invoked. Personnel were not provided a stopping point short of total task completion. The AD was working with the provided equipment, and with a portion of his upper body inside the MGS, when material broke free and/or dislodged and entrapped him causing the traumatic injury that ultimately resulted in his death.

BSEE recommends that companies operating on the U.S. Outer Continental Shelf:

- Ensure that authorizing personnel take an active role in task planning and verify that all required task authorization documents are complete, accurate and meaningful.
- Ensure that hazard analyses are updated or revised to reflect all impactful changes in task conditions, and/or the working environment.
- Ensure that equipment approved and made available for each assigned task is adequate to perform the task-work safely and in accordance with safe work practices and work instructions.
- Clarify through initial and/or recurrent training how "confined space" and "entry" are defined.
- Evaluate emergency response plans and supporting response organization agreements to ensure everything is adequately in place to support your emergency response plans and strategies.
