# SAFETY ALERT

**Safety Alert No. 385**  
**May 15, 2020**

## Improper Installation of Safety Devices on Heater Treaters

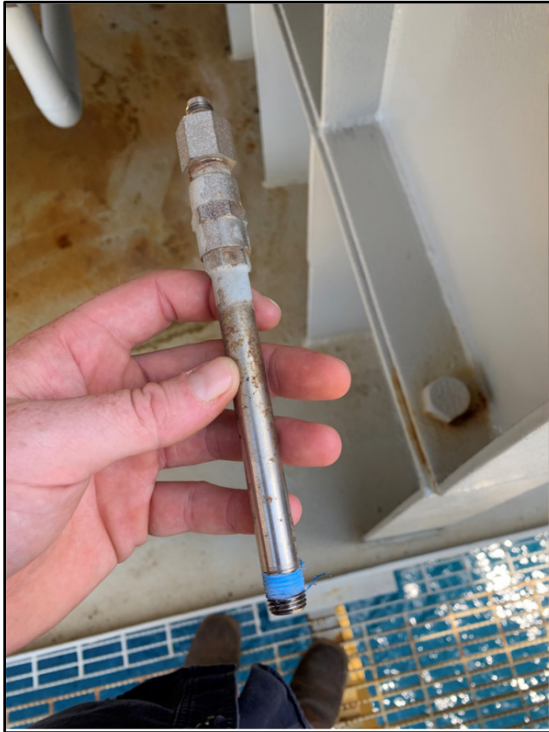
*A Temperature Safety High (TSH) with Teflon tape on the threads. Teflon tape reduces the heat sink effect.*

- Improper installation of TSH safety devices, such as the use of Teflon tape during installation of a media device: The threads on the TSH are part of the heat sink process and Teflon tape reduces heat sink.
- Inadequate length of a media Temperature Indicator (TI): When a TI remains inside a vessel's nozzle and does not extend into the media, it can lead to inaccurate temperature readings.
- Partially plugged Flame and Stack Arrestors did not allow proper airflow or heat to escape.

- Ensure the thermowells for the liquid media's TSH and temperature indicator/gauges extend far enough past the vessel's nozzle and into the media to get correct temperature readings;
- Confirm that all safety devices and critical indicators are installed correctly prior to initial start-up;
- Ensure safety devices, such as TSHs, are installed in accordance with manufacture recommendations and not with Teflon tape;
- Verify that scheduled maintenance and inspections on safety devices are performed as required;
- Consider inspecting flame arrestors and stack arrestor devices periodically and replacing them when damaged; and,
- Consider inspecting and replacing TSH devices periodically to ensure proper temperature safety management of fired vessels. Note: This device generally cannot be field tested.

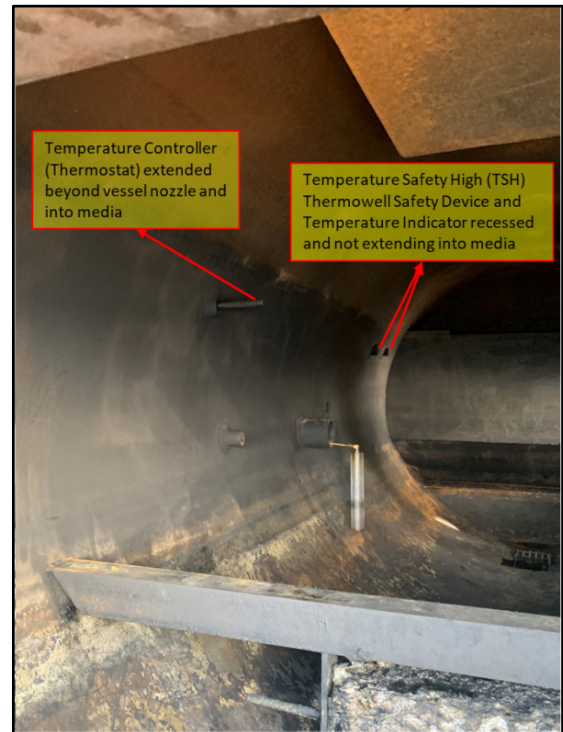
*The TSH is not extended far enough into the heat media. As a result, the Temperature Indicator (TI) is unable to register a proper temperature.*

- Inadequate length of Temperature Safety High (TSH) safety device thermowells: The thermowells often did not extend into the media, leading to inaccurate temperature readings and the TSH not functioning as desired.
