# SAFETY ALERT

**Safety Alert No. 344**  
**6 December 2018**

## **Chemical Release due to Containment Failure**

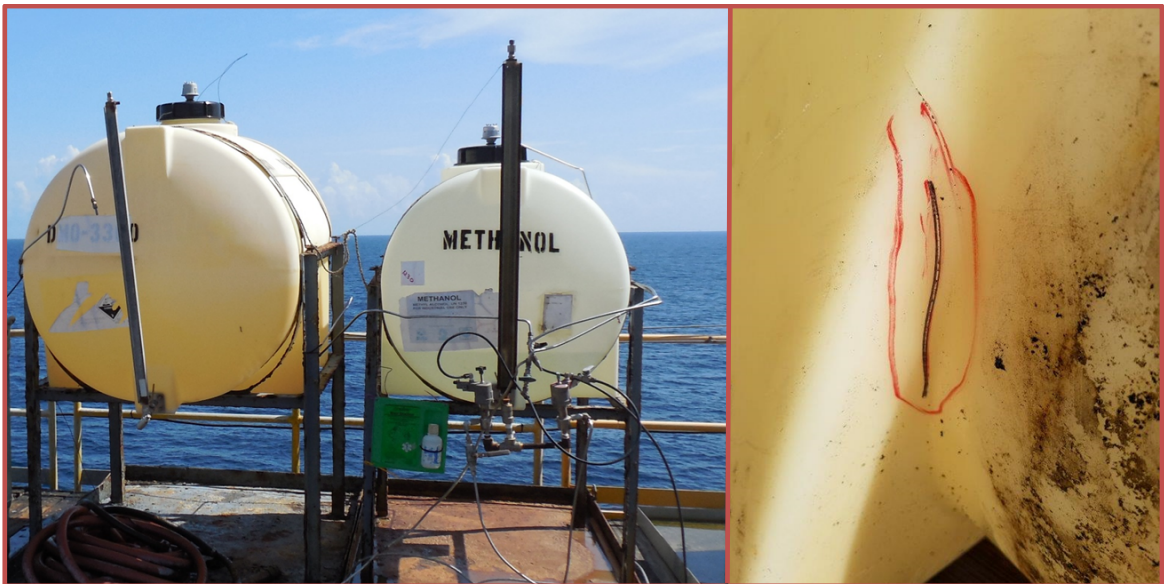
*Location of storage tank (tank on left) at the time of the incident (left photo) and external view of the crack (right photo)*

- The discharge was due to a crack along bottom area of the polyethylene tote (see photos).
- The interior of the tote’s walls showed dimples and reduced wall thickness throughout the fluid contact area.
- The tote was improperly labelled as containing “Corrosive” versus “Flammable” contents per the Safety Data Sheet.
- The secondary containment pan had filled with rain water and was incapable of retaining the totes contents.

- The chemical was stored in an improper container, as polyethylene totes are incompatible with xylene. The degree of degradation/damage caused by improperly storing the emulsion breaker in the polyethylene tote and its role in the tote's failure of primary containment is not known, but is considered a contributing cause.
- The tote was exposed to sun/weather and had been in service for over five years. The exposure to UV/elements may have contributed to the tank's failure.
- There should be a means for removing rainwater from the secondary containment, allowing room to contain any chemical spillage.
- The tote was improperly labeled which could increase risks to personnel and the environment.

- Ensure the compatibility of storage totes with the chemicals they are designated to store, in accordance with the safety data sheet (SDS);
- Properly label all chemical storage containers;
- Ensure all personnel are properly trained and fully understand the implications of the chemicals used on their facilities;
- Evaluate and inspect all chemical storage containers and supporting structures to ensure they are fit for continued service.
