SAFETY ALERT

Safety Alert No. 354
6 June 2019

Fire in Smoking Area Linked to Cigarette Butt Container

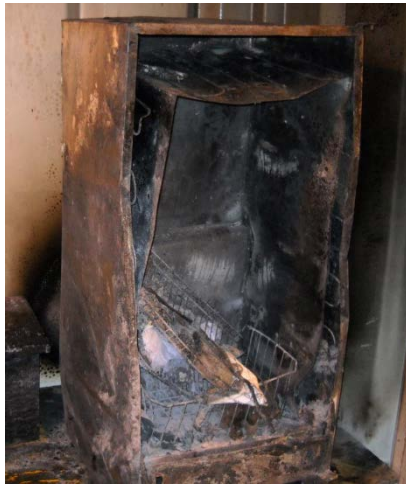
Damaged Freezer after fire.

Recently, personnel on an offshore platform, smelled smoke and exited their quarters to find a small unplugged freezer in the smoking area engulfed in flames. Personnel extinguished the fire using fire extinguishers and doused all smoldering areas until the situation was brought under full control. It was determined that a plastic cigarette butt container had ignited, and the resulting flame spread to the freezer, another cigarette butt container, a plastic trash can, and the plywood support upon which all were located. The original butt container from which the fire emanated was completely consumed by the fire.

- Ensure all cigarette butt containers are not in the vicinity of combustible items.
- Create and enforce a policy for periodically emptying each cigarette butt container to avoid overfilling and the resultant fire hazard.
- Place every cigarette butt container on a noncombustible surface.

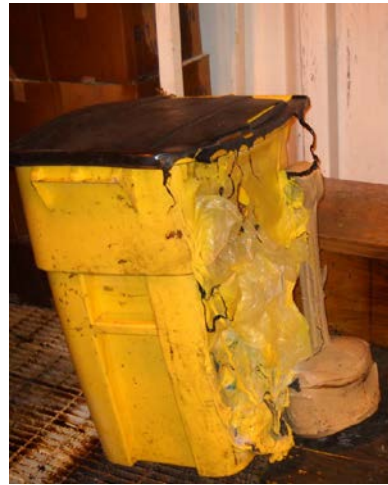
Damaged Trash Can and Cigarette Butt Container

Although exact details about the ignition source remain unknown, the operator's investigation determined it was possible that a hot cigarette in an overfilled butt container ignited the other butts and the container before spreading and burning for as long as 20 minutes.
