SAFETY ALERT

Safety Alert No. 439

Toppled Hydraulic Workover Unit Results in Fatality

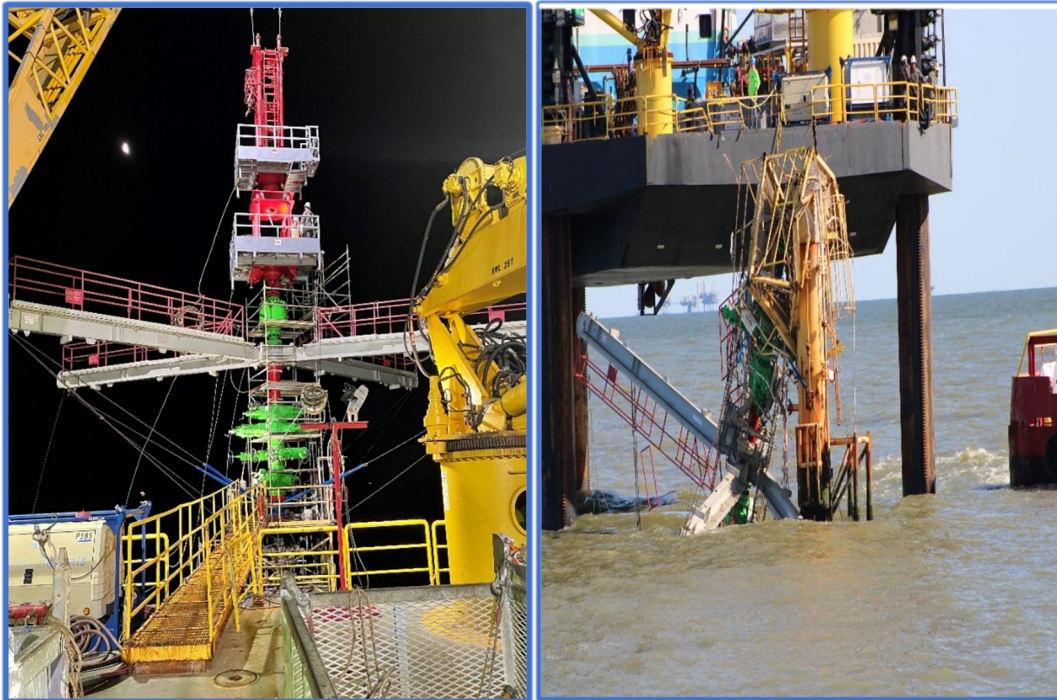
Hydraulic Workover Unit Before(left) and After (right) Fatal Incident

Recently, a hydraulic workover unit (HWU) toppled while being erected on a caisson located in 35-feet of water in the Gulf of Mexico, resulting in a contractor employee falling into the water. The HWU, consisting of a blowout preventer (BOP) and pipe jack assembly weighing approximately 120,000 lbs., was installed on the wellhead and attached to a 20-inch structural casing. Preliminary observations indicate a break in the casing at the production tree or just below the drive pipe which resulted in the HWU and tree falling over. At the time of the toppling, one contractor employee was elevated on the HWU and tied off with a safety harness for fall protection but fell into the water with part of the HWU.

While this is a preliminary safety alert, BSEE recommends that operators and contractors consider the following:

- Increasing awareness of the dangers inherent in rigging up HWU, or non-rig units, with work environments that make it difficult to tie-off when fall protection is used.

- Reviewing the fall protection design and determining whether quick release of emergency cut-away mechanisms may be used without compromising overall safety or creating new risk.

- Ensuring a reliable means of support exists whenever a HWU, or non-rig unit, is being unhooked from the crane.
- Ensuring your facility and connection points can support the installed equipment and the max pull capacity available during workover operations.

- Reviewing the planning process to ensure a detailed review if unique or unusual operations are contemplated. And if incorporated, including the new processes as part of the agenda for safety meetings and training.

- Ensuring onsite supervision is fully qualified for the planned operations.
- Ensuring the details of all plans are fully communicated and understood.
- Placing special emphasis on the Job Safety Analysis process and shift hand-off meetings to ensure that all personnel and supervisors are involved in the process.

- Considering seasonal weather patterns when installing means of support for HWU or non-rig units.
- If structural damage is found in Level I, II, or III surveys, completing a structural analysis and performing any repairs before connecting equipment such as BOPs, workover, and snubbing, coil tubing units, etc.
