# SAFETY ALERT

**Safety Alert No. 342**  
**25 October 2018**

## Failure of Crane Hydraulic Boom Cylinders

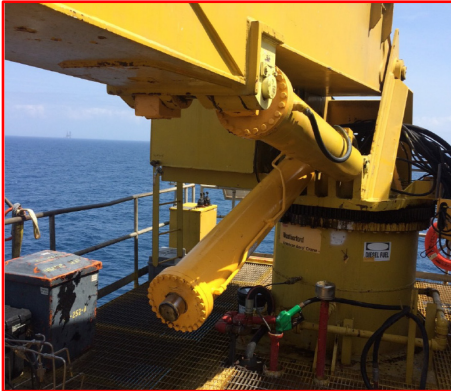
*26 March cylinder failure*

- 26 March 2018: A hydraulic boom cylinder (HBC) installed on 3/24/18 on a platform crane was compromised when the cylinder rod separated from the cylinder rod eye. As a result, the cylinder dropped to the decking below. Because there are two cylinders on the crane, as shown above left, the failure did not cause the boom to collapse.
- 25 April 2018: A replacement for the failed cylinder described above was installed on 4/1/18. On 4/25/18 the replacement cylinder suffered the same exact failure. In this instance, the replacement cylinder fell and hit a handrail, as shown above right.

- In the instances where the failures occurred, the pin-to-pin lengths of the cylinders involved were different. This was due to different rod lengths.
- This difference between cylinders working in tandem resulted in the shorter length cylinders experiencing stress at the rod pin coupling.
- This stress, in combination with an inferior weld, resulted in a failure of the rod pin coupling and rod connection. This failure resulted in the rod separating from the rod pin coupling, causing the cylinder to fall.

- Ensure equivalent eye-to-eye rod length of HBCs when repair of one HBC is necessary.
- Review current crane cylinder configurations.
- Regardless of the manufacturer of the HBCs, BSEE recommends making the OEM of your crane boom aware of these failures, and further recommends that the operators obtain any needed replacement HBCs from the OEM, or a certified manufacturer.

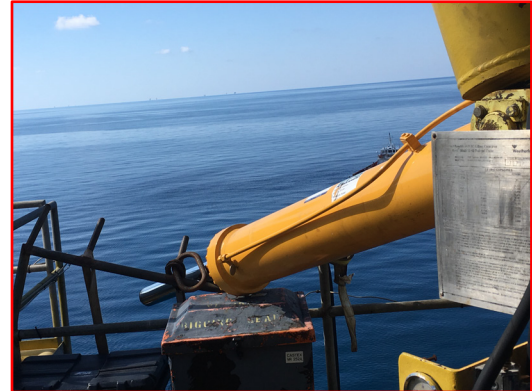
*25 April cylinder failure*
