SAFETY ALERT

Safety Alert No. 368
October 4, 2019

Inadvertent Opening of Valve Under Pressure Causes Injury

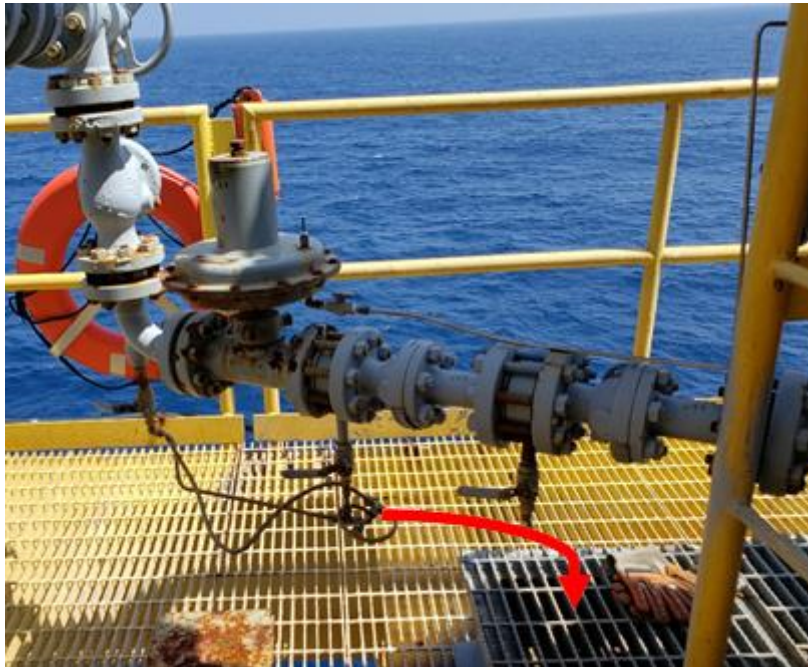
The lower left quarter of this photograph shows the twisted drain line tubing after the pressure release occurred. The red arrow indicates the pre-incident orientation of the drain line.

On May 20, 2019, an offshore oil and gas worker was conducting daily rounds, which included checking for fluid in the gas lift fluid slug catcher. The worker noticed that the drain line to the associated containment pan was leaking. The worker attempted to close a ½-inch ball valve that drains to the catcher containment pan, but instead of closing it, the worker inadvertently opened the valve, releasing approximately 1200 pounds per square inch (psi) of pressure. This pressure release caused the drain tubing to dislodge from the containment pan and strike the worker, fracturing the worker's nose.

BSEE determined that four main factors led to the incident:

1. A dump valve system was installed six months prior, making the drain line tubing and ball valves unnecessary; however, these components had not been removed and capped.

2. The Job Safety Analysis (JSA) did not specifically identify and address hazards associated with working with pressurized equipment.
3. The injured worker opened the valve instead of closing the valve;
4. The drain line tubing was only supported by a zip tie, which offered little resistance when pressurized.

Therefore, BSEE recommends that operators consider the following:

- Use a manual control valve (e.g., needle valve) that allows for flow in place of valves (e.g. ball valves) that don't allow for a regulated pressure drop if sampling/bleeding operations are required;

- Verify that JSAs identify potential hazards and mitigate those hazards for the task being performed;
- Ensure that, when changes are made to equipment, all hazards are identified and mitigated through the Management of Change (MOC) process. Update facility information and inform all personnel affected by the change(s);

- Install tubing lines used for draining/bleeding process equipment with a minimum amount of bends/angles to eliminate pressure resistance;
- Do not use drain tubing longer than necessary;

- If extended lengths of tubing are necessary, secure tubing drain lines with appropriately designed materials and techniques to prevent potential movement.

- Verify current platform conditions are reflected on piping and instrumentation diagrams (P&IDs).
