**Safety
Alert**

Safety Alert No. 313
31 July 2014

Snake Grip Failure on Drill Line

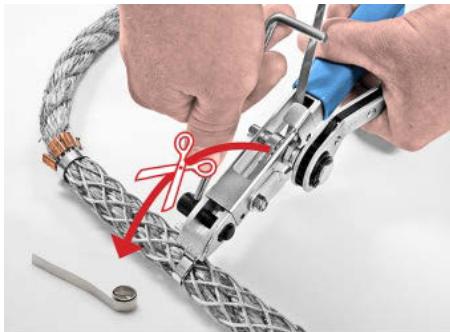
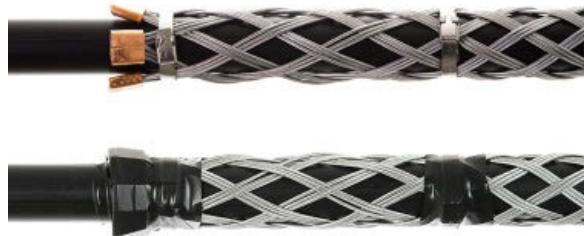
- The International Association of Drilling Contractors (IADC) issued Safety Alert #11-20 titled, “DRILL LINE PULLS THROUGH WIRE ROPE SNAKE WHILE STRINGING BLOCKS.” Safety Alert #11-20 was issued August 2011. This Safety Alert addressed the importance of properly degreasing the wire cable prior to utilizing the snake grip equipment.
- Snake Grips are also known as: ‘Chinese Finger Locks’ or ‘Socks’.
- Below are examples of the proper banding and taping applications.

- Drill line cables must be thoroughly degreased before insertion into snake grip.
- Use the proper manufacturer recommended clamps and tools to secure the snake grip to the cable.
- Maintain a safe operating speed on the drill line winch to ensure safety observers have adequate time to relay any and all safety concerns during operation.
- Be assertive in personnel placement while conducting this type operation. When possible, keep personnel clear of drop zones of all the overhead equipment and work.
