# SAFETY BULLETIN

**Safety Bulletin No. 004**  
**June 16, 2017**

## **Mud/Gas Separator Cleaning Results in Death**

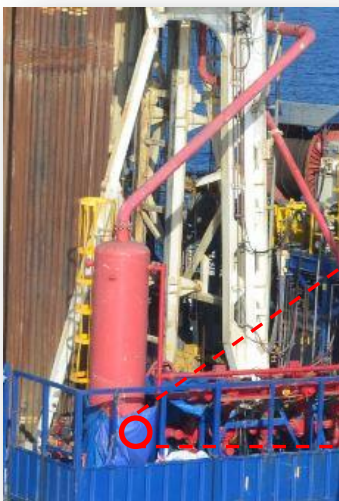
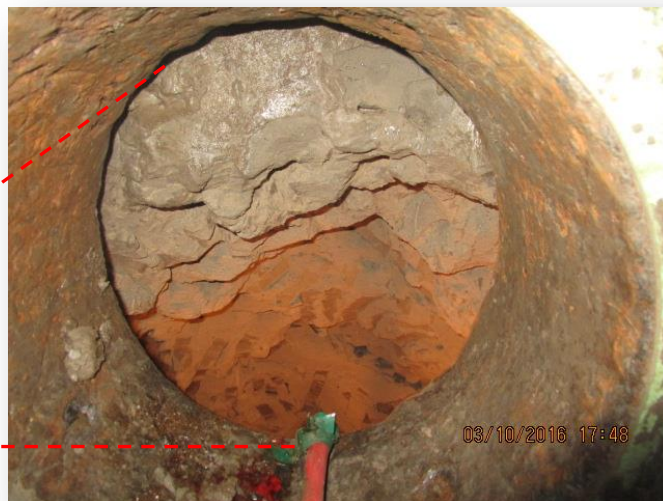
A fatal incident occurred when an Assistant Driller (AD) placed his head and an arm into a platform drilling rig's vertical Mud/Gas Separator (MGS) through its inspection hatch while performing the assigned, but non-routine, task of removing built up and hardened material from inside the MGS.

material built up inside the MGS was enough to reach the height of its (MGS') internal baffles. This led to the belief that the baffles would support and prevent the overhead material from falling. Despite some of the workers having expressed individual concerns about the task conditions, stop work authority was not invoked. Personnel were not provided a stopping point short of total task completion. The AD was working with the provided equipment, and with a portion of his upper body inside the MGS, when material broke free and/or dislodged and entrapped him causing the traumatic injury that ultimately resulted in his death.

- Ensure that authorizing personnel take an active role in task planning and verify that all required task authorization documents are complete, accurate and meaningful;
- Ensure that hazard analyses are updated or revised to reflect all impactful changes in task conditions, and/or the working environment;
- Ensure that equipment approved and made available for each assigned task is adequate to perform the task-work safely and in accordance with safe work practices and work instructions;
- Clarify through initial and/or recurrent training how "confined space" and "entry" are defined;
- Evaluate emergency response plans and supporting response organization agreements to ensure everything is adequately in place to support your emergency response plans and strategies.
