## **Reliability of Deepwater Subsea BOP Systems and Well Kicks**

**Unrestricted Version**

Per Holand and Hammad Awan

August 2012

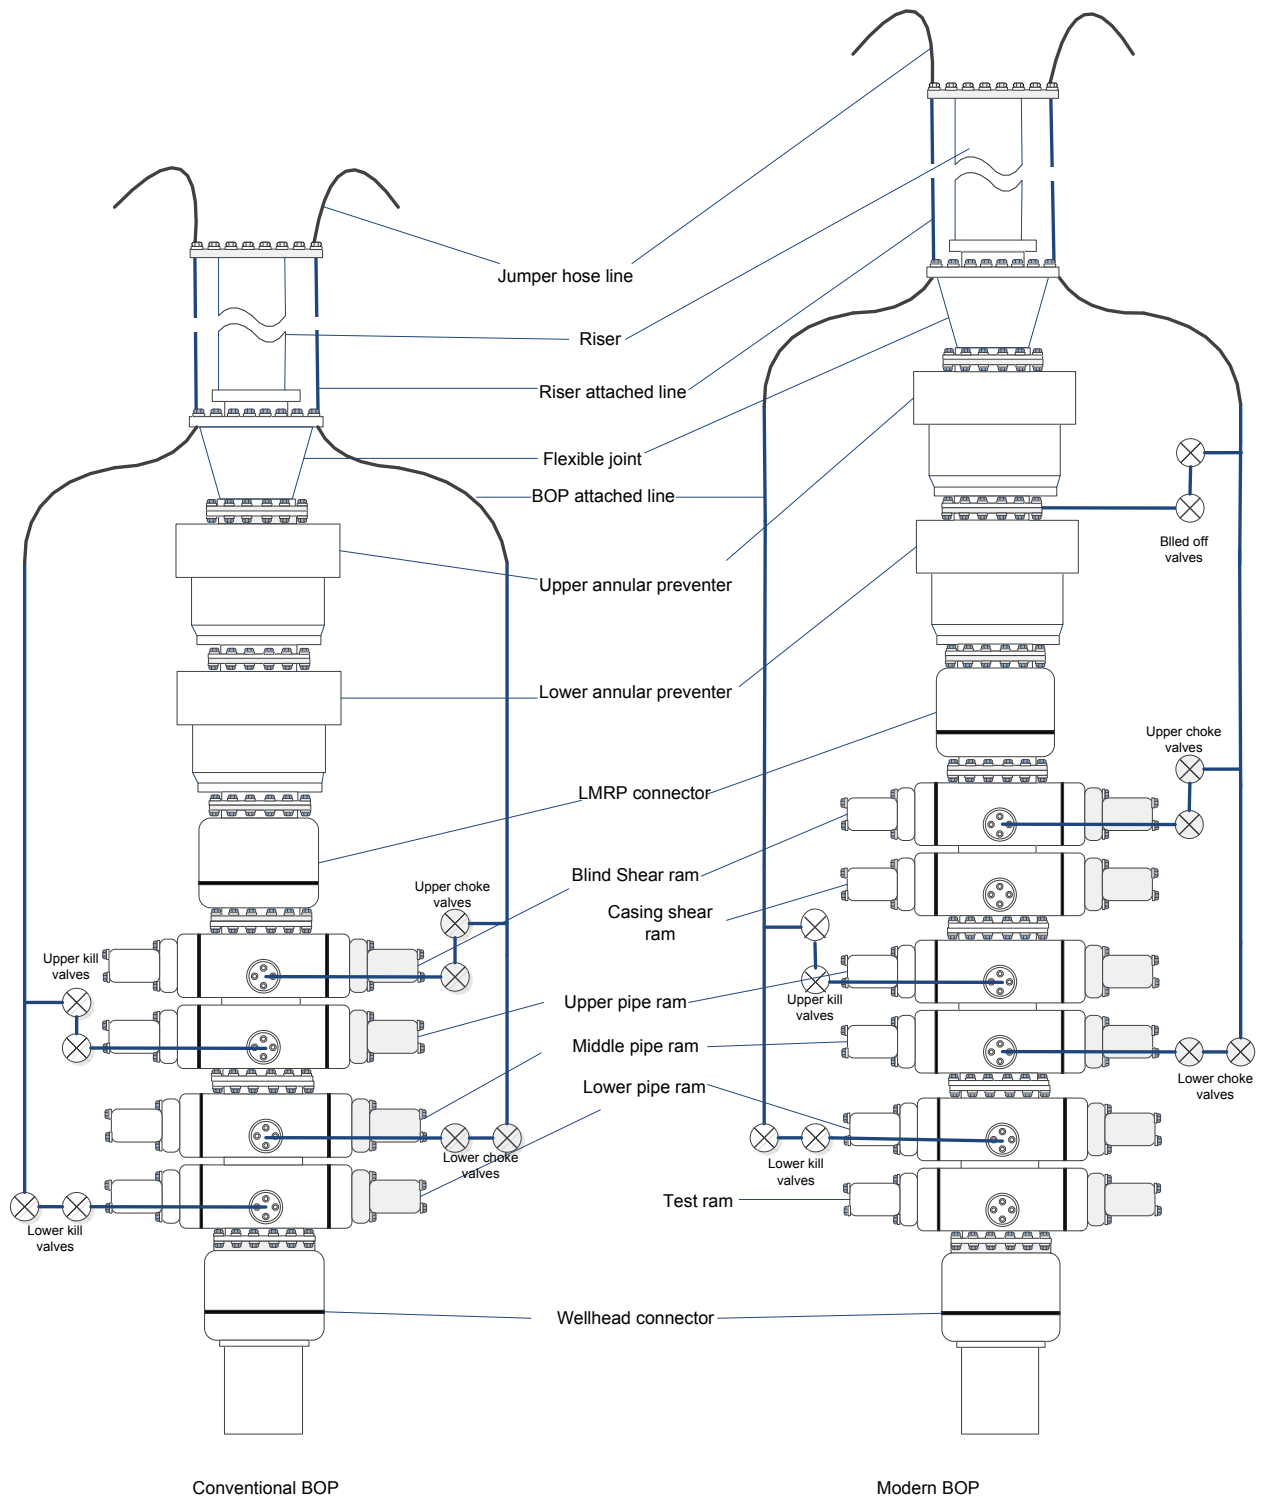
**Figure 3.1 Typical BOP configuration**

Table 3.1 shows an overview of the BOP configuration of rigs that are included in the study. The BOP stacks were all 18 3/4", mostly 15 000 psi rated and some few 10 000 psi rated. Seven of the drilling vessels were drill ships while 35 were semisubmersible rigs. All the drillships were dynamic positioning type and most of the semisubmersible rigs were anchored.

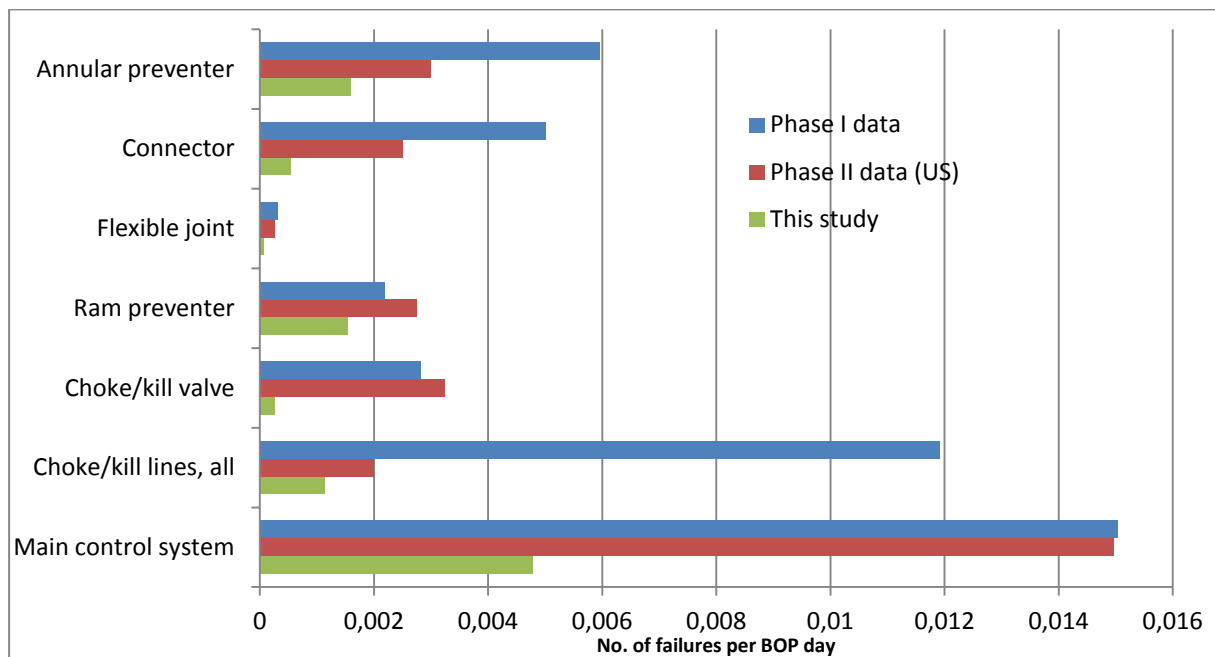
**Figure 3.5 Comparison of BOP item specific failure rate with previous studies**

In this study, 29 out of 42 rigs have multiplex control system, while in the previous study most of the rigs had pilot hydraulic control systems.

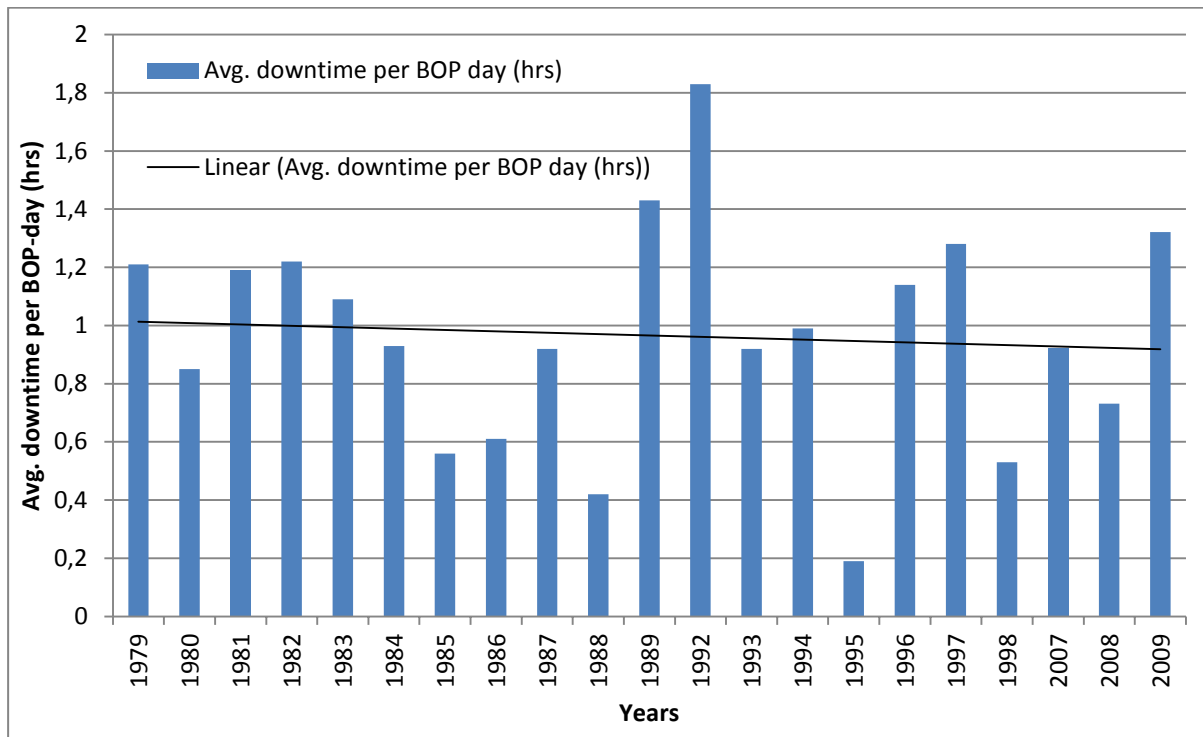
**Figure 3.8 Average downtime per BOP-day and associated trend lines for the period 1979 – 2009**

In Figure 3.8 the average downtime per year and the associated trend lines for the average downtime per day in service are shown.

As seen from Figure 3.8, a slight reduction in the downtime per day in service is indicated by the trend lines. This is however, not a significant trend. If only regarding the period 1983 – 1996 and 2007 – 2009, a slight increase in downtime per day in service is observed. This is also to be expected since handling time increases with the water depth and large part of the most recent data is from deepwater wells.

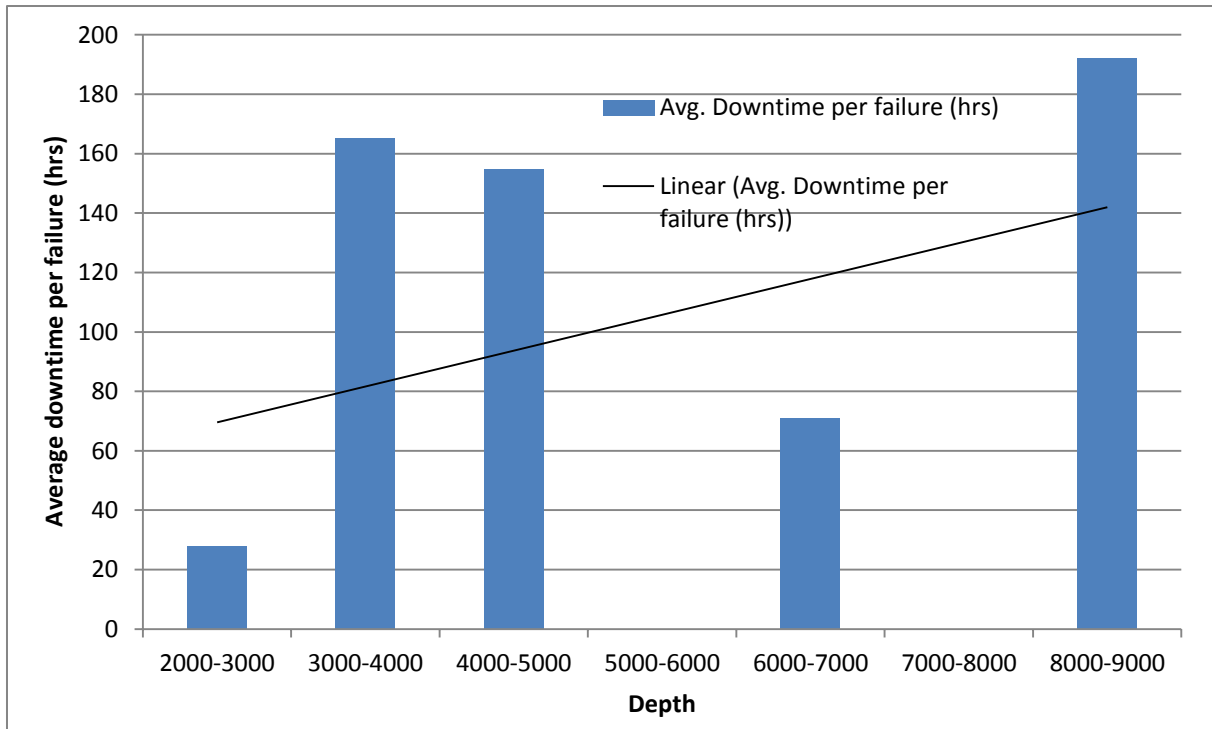
**Figure 4.1 Annular preventer Avg. downtime per failure Vs. depth**

Figure 4.1 shows the average downtime per failure vs. water depth. A general increasing trend can be observed. There were eight failures without any associated downtime. For these, the failures were accepted due to its low severity.

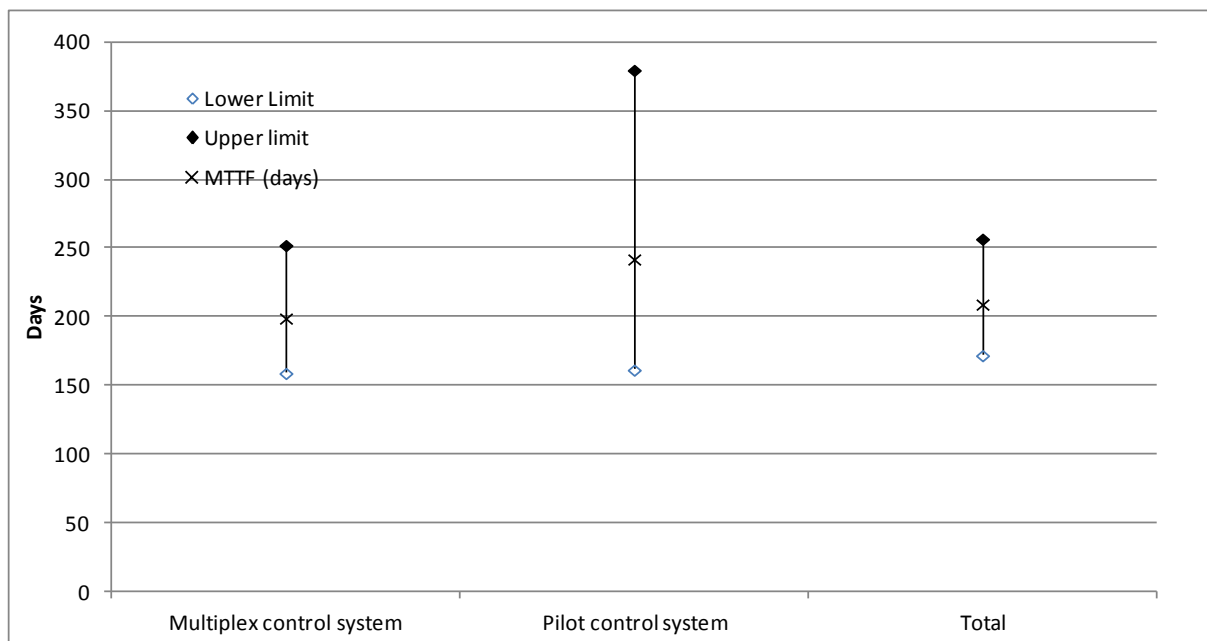
**Figure 4.2 MTTF comparison, BOP control system principles with 90% confidence limits**

A comparison of MTTFs for the different operating principles of the main control systems is shown in Figure 4.2. It can be seen that there is no significant difference between the MTTFs since the confidence bands are overlapping. This is the same observation as in Phase I & II DW studies (/1/ and /3/).

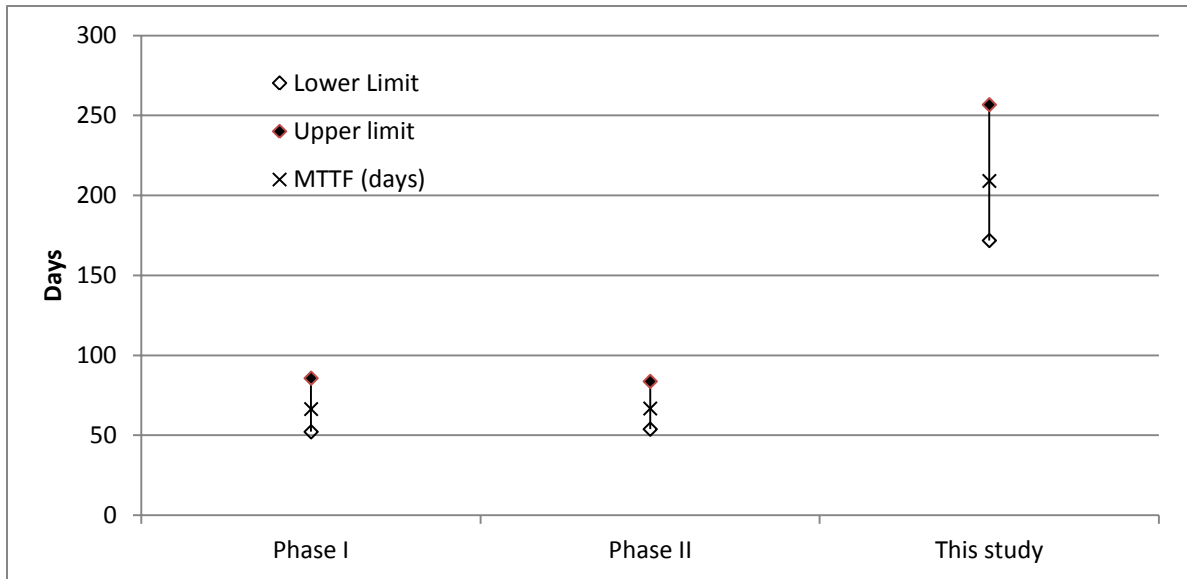
**Figure 4.3 Comparison of Control System MTTF (average with 90% confidence limits) with Previous Studies**

A comparison of control system failures with previous studies (/1/ and /3/) is shown in Figure 4.3. It can be seen that the current study has significantly higher MTTF than the Phase I & II. The reasons for this are discussed in Section 3.6.

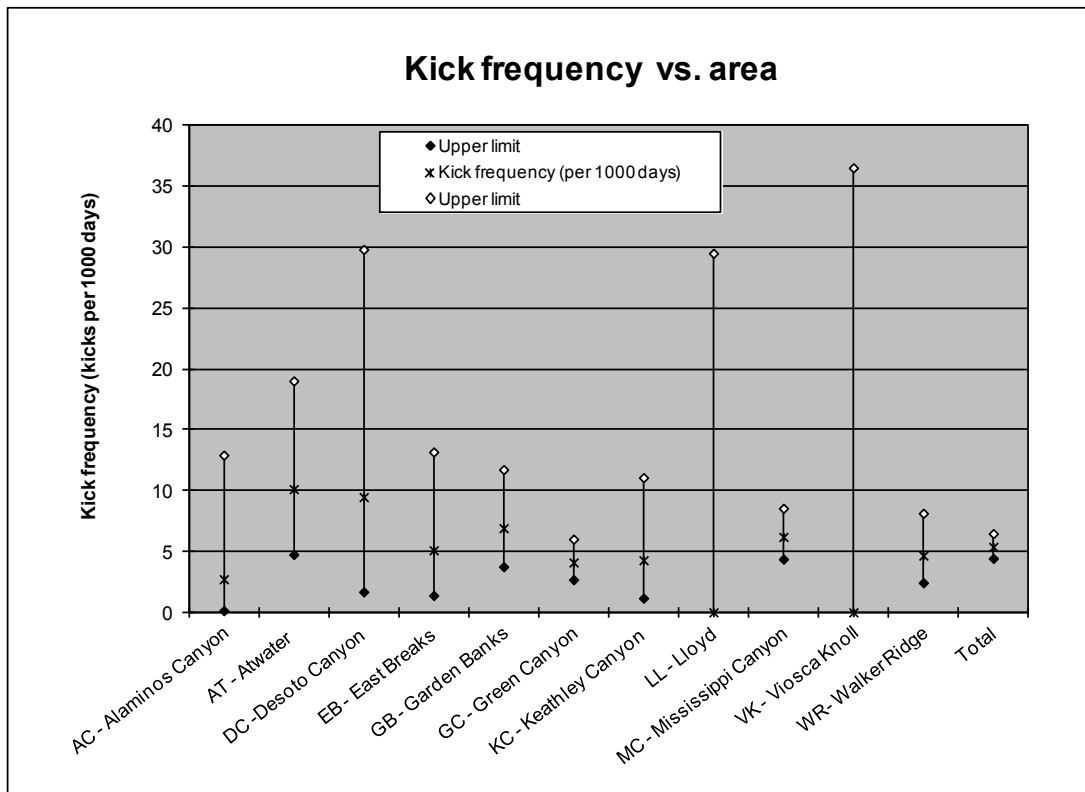
**Figure 8.2 Kick frequency vs. area**

To check whether the differences in kick frequency between the different areas were statistically significant or not, 90% confidence limits are established for the kick frequencies. Figure 8.2 shows the area specific kick frequencies alongside the 90% confidence bands.

Figure 8.2 cannot confirm a statistical significant difference between the areas.

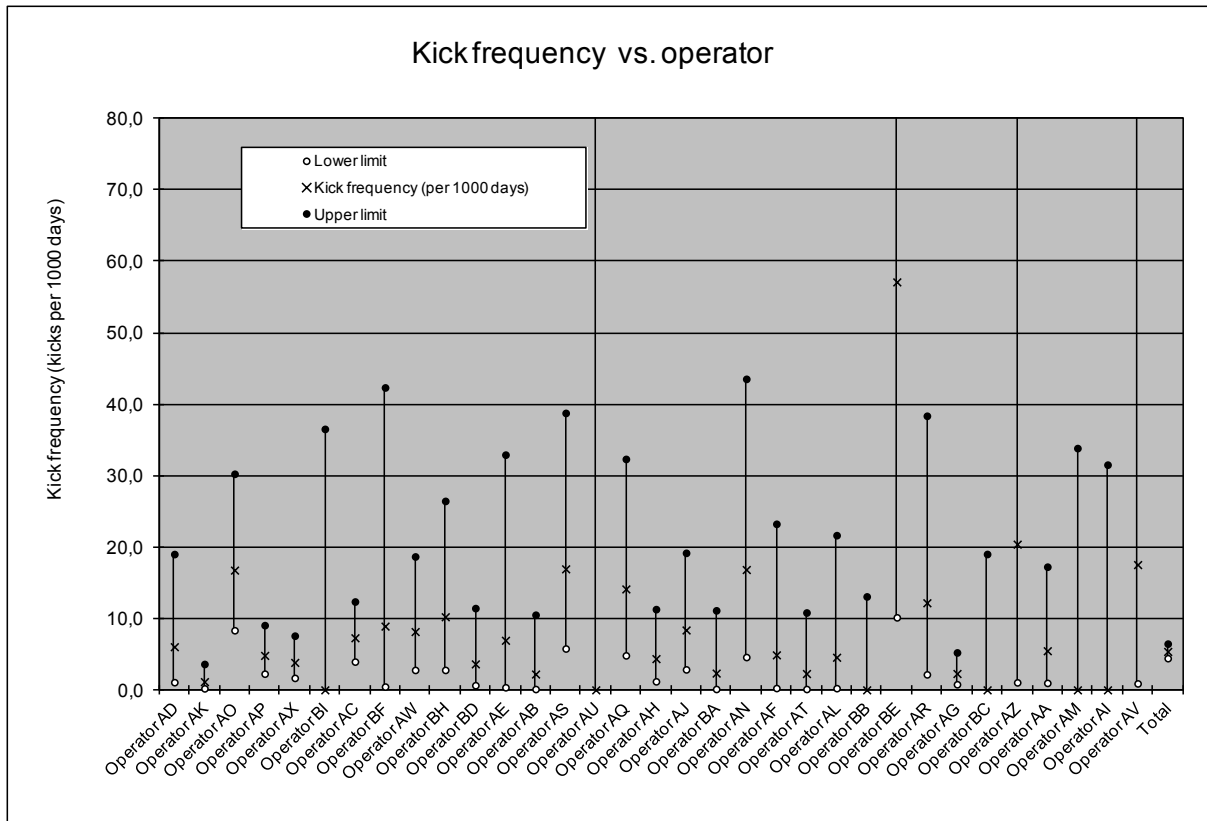
**Figure 8.4 Kick frequency vs. operator**

Many operators have been drilling deepwater wells in the US GoM OCS in 2007-2009. The average MTBK varies highly. It is here important to note that each of the companies is represented with relatively few days in service. Figure 8.4 shows the kick frequency vs. operator alongside the 90% confidence bands.

As seen from Figure 8.4, some operators have a significantly lower kick frequency than other. It is here also important to note that different wells have different difficulties when drilling, i.e. some wells kicks easier than others. The average MTBK should therefore not be used for ranking the operators.

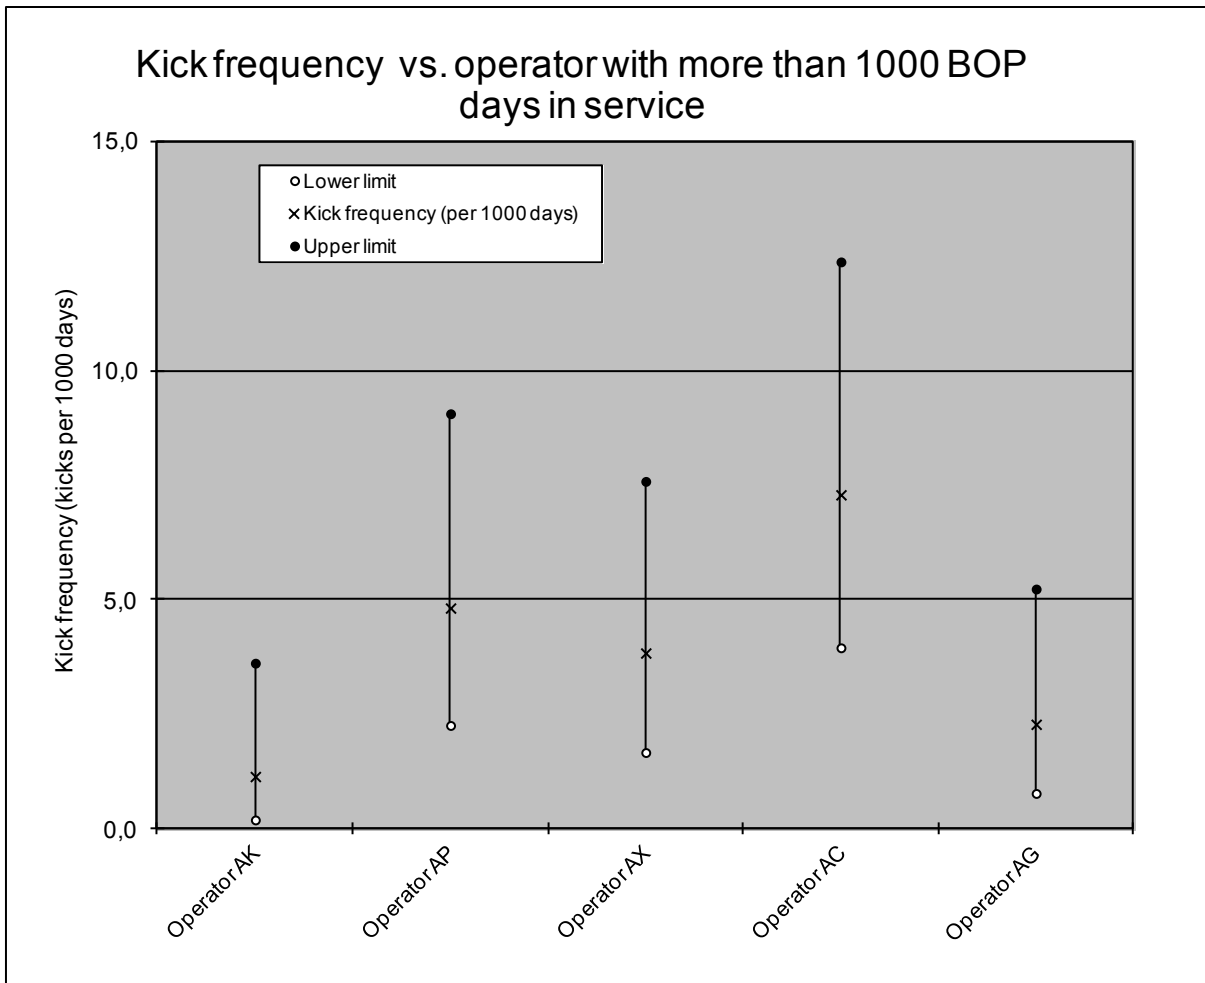
**Figure 8.5 Kick frequency vs. operator for operators with more than 1000 BOP-days in service.**

Five operators have more than a 1000 BOP-days of experience in this dataset. These five operators have carried out approximately 50% of the drilling. Figure 8.5 shows the kick frequency vs. operator alongside the 90% confidence bands for the five operators represented with more than 1000 BOP-days in the study.

It is worth to note that Operator AK kick frequency is the lowest. This frequency is significantly lower than the Operator AC kick frequency. Most of the drilling Operator AK have been doing is exploration drilling. It has however not been investigated if there are specific reason for this low kick frequency.

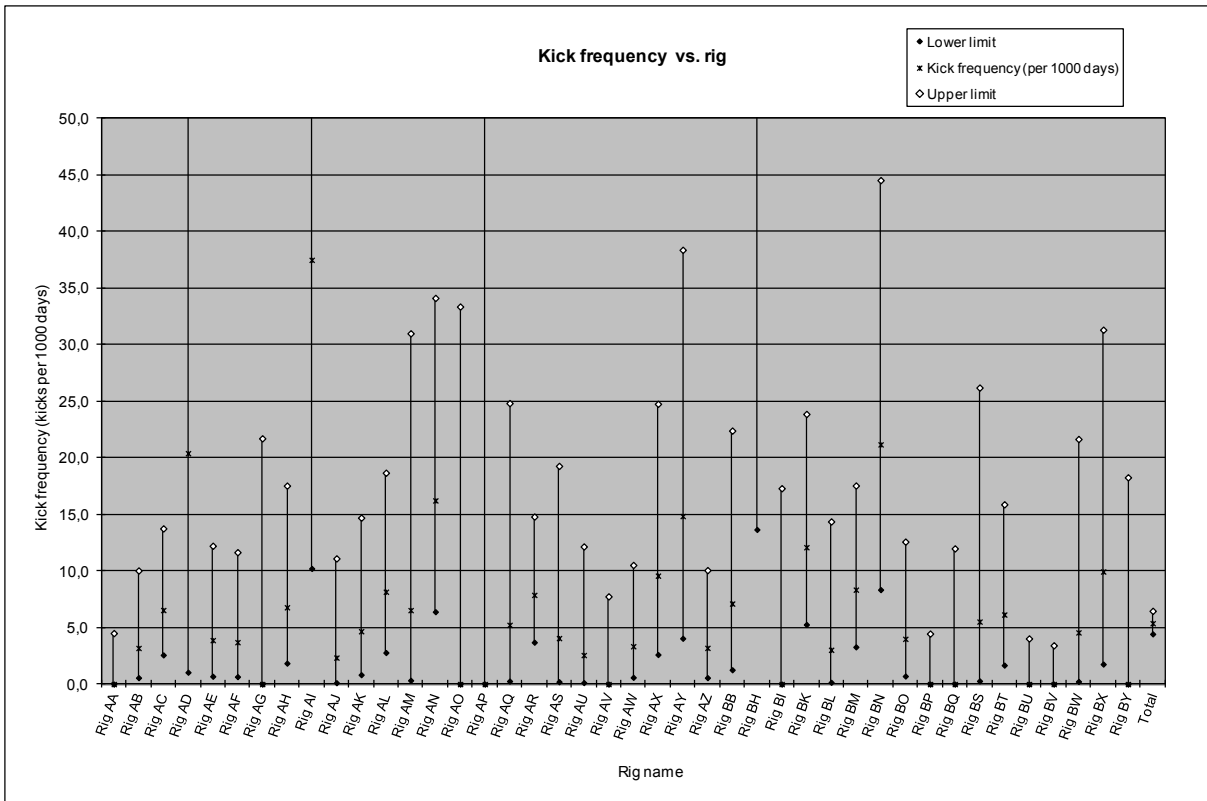
**Figure 8.7 Kick frequency vs. rig**

Many different rigs have been drilling deepwater wells in the US GoM OCS in 2007-2009. The average MTBK varies highly. It is here important to note that many of the rigs are represented with relatively few days in service. Figure 8.7 shows the kick frequency vs. operator alongside the 90% confidence bands.

As seen from Figure 8.7 the confidence bands overlap for most of the rigs. It is here also important to note that different wells have different difficulties when drilling, i.e. some wells kicks easier than others. The average MTBK should therefore not be used for ranking the rigs.

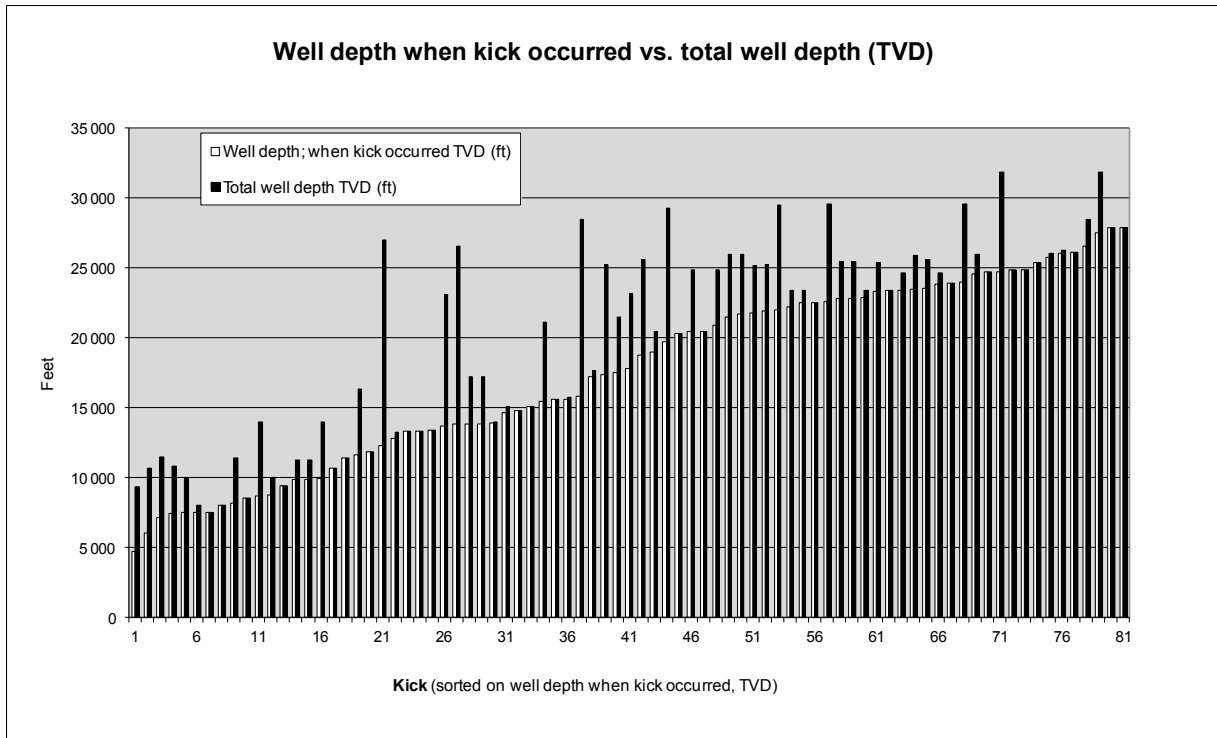
**Figure 9.3 Well depth when the kick occurred vs. the total well depth (TVD)**

Figure 9.3 shows the well depth when the kick occurred vs. the total well depth.

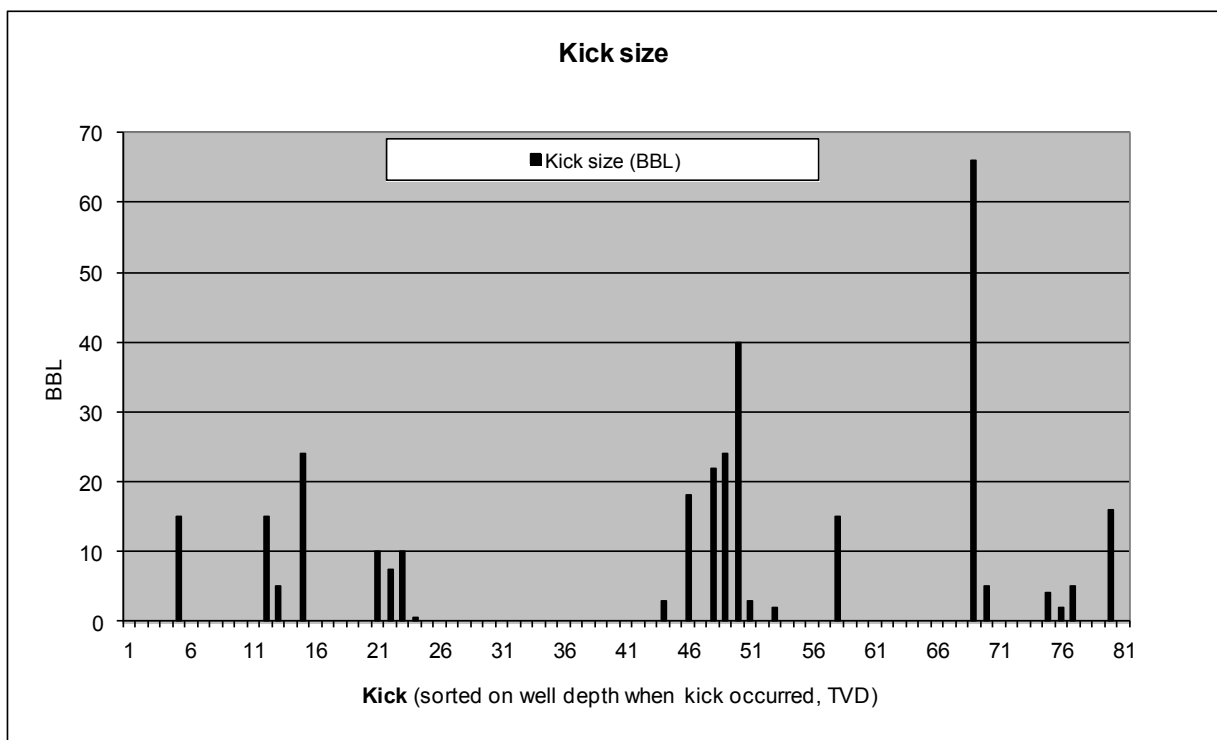
**Figure 9.5 Kick size**

Figure 9.5 shows the kick sizes recorded.

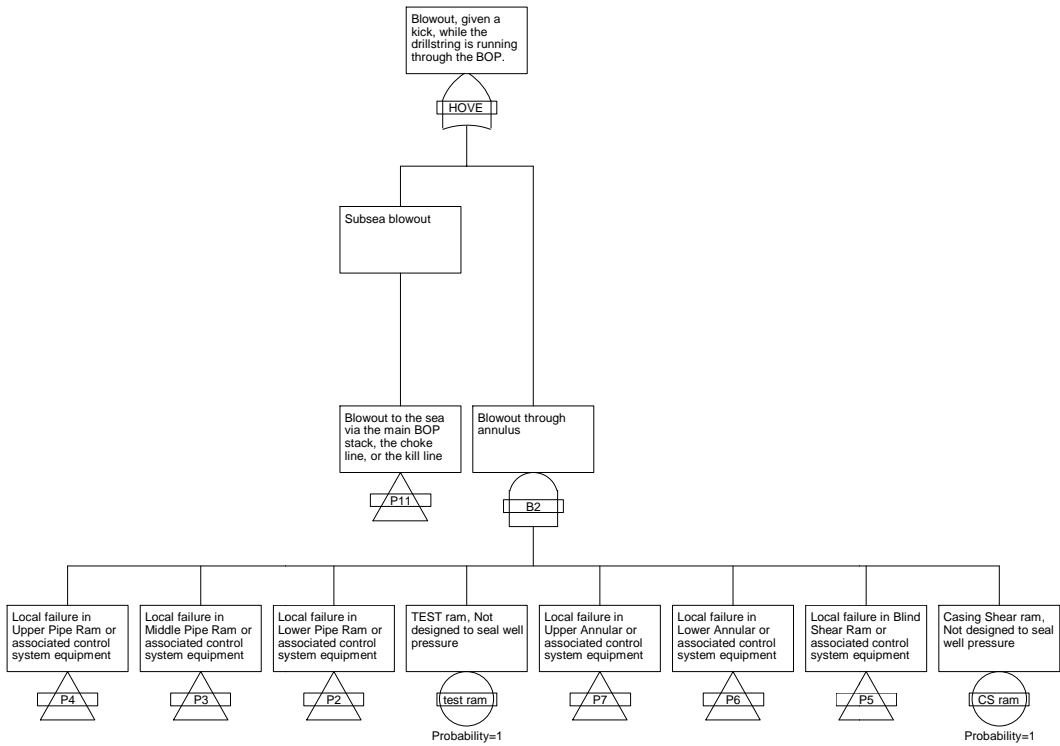
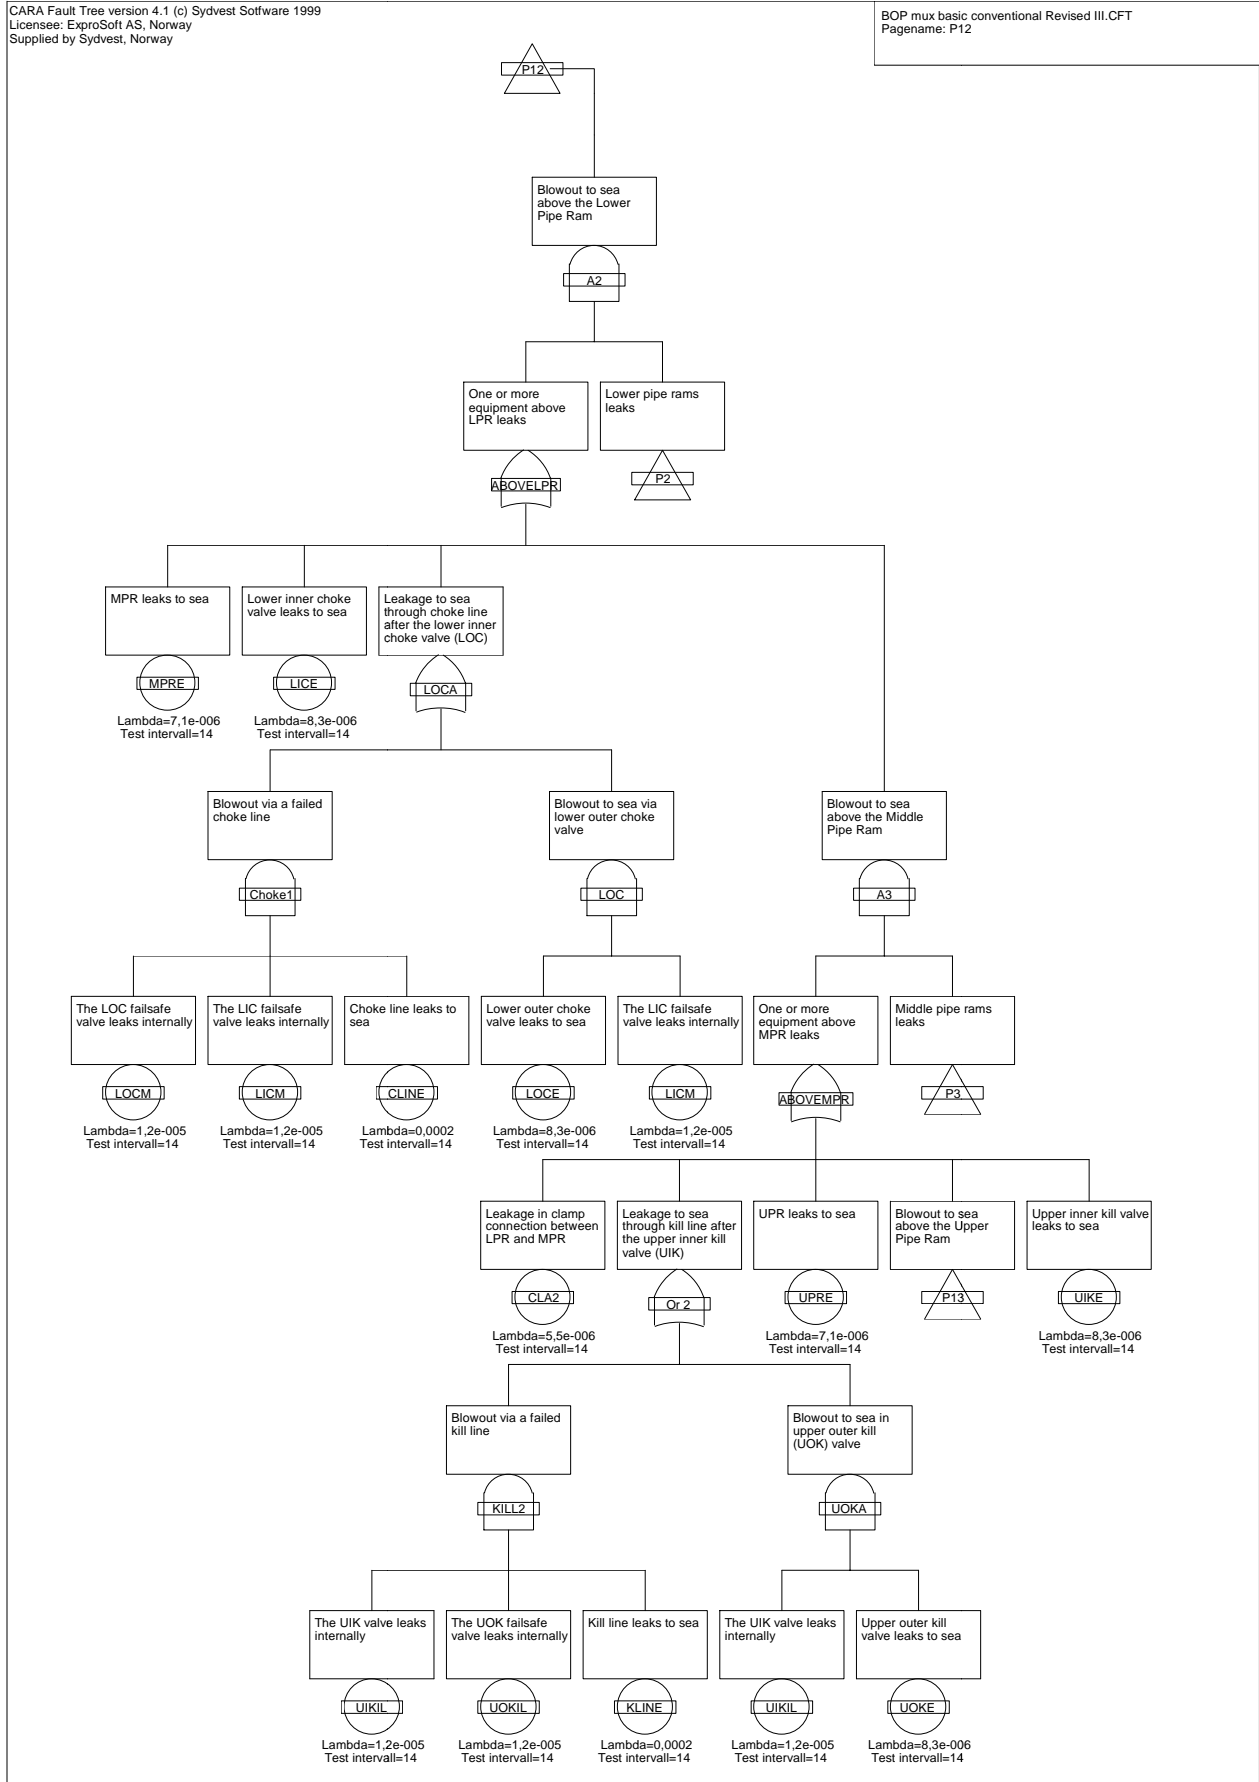
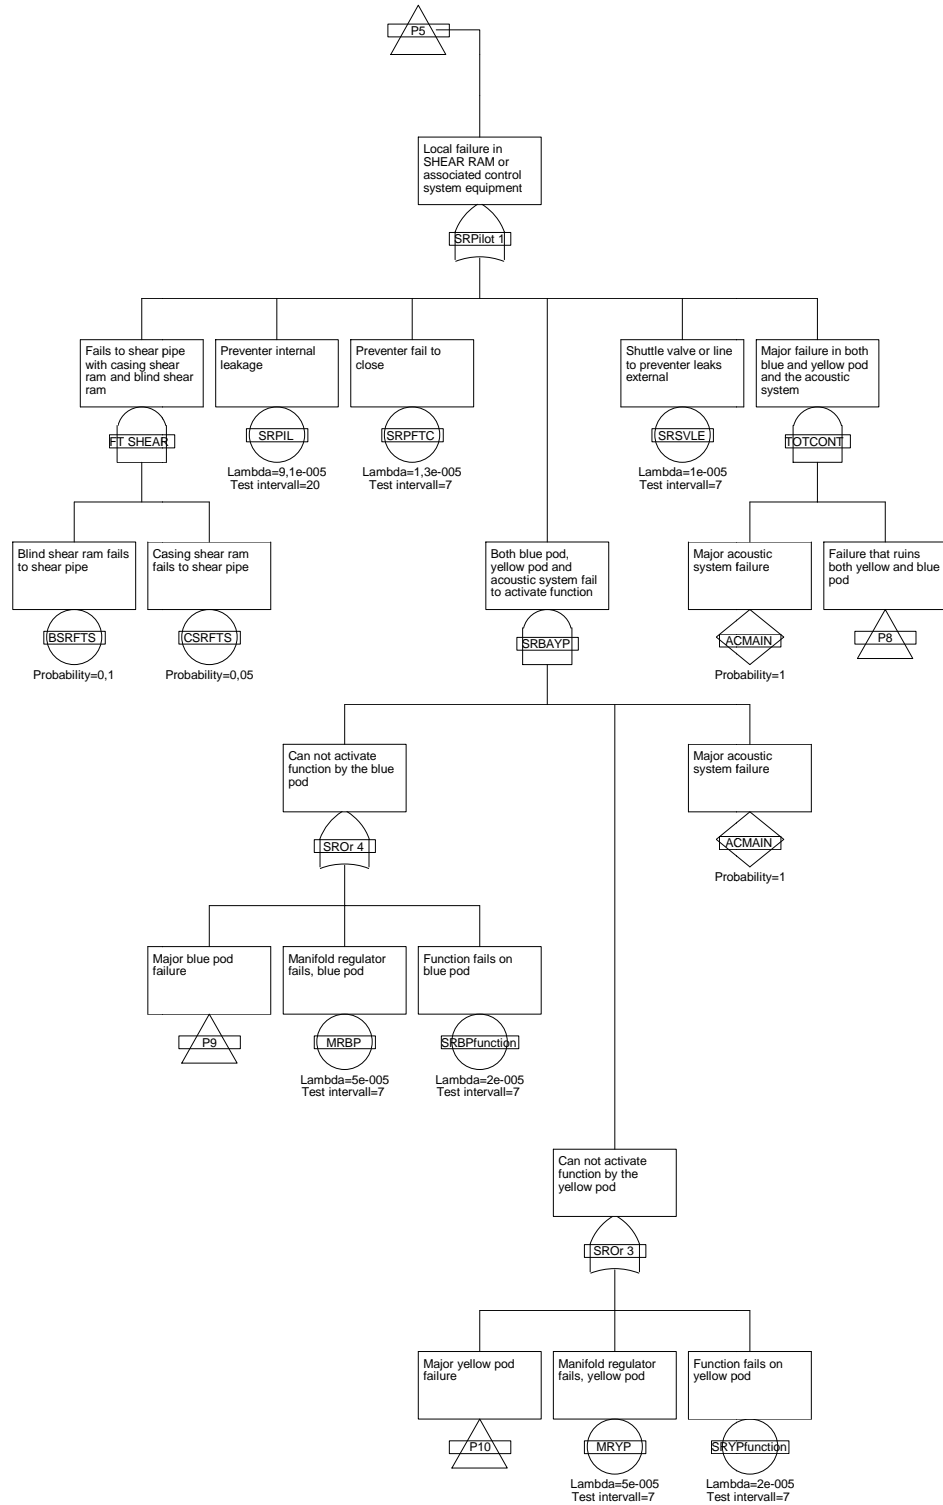
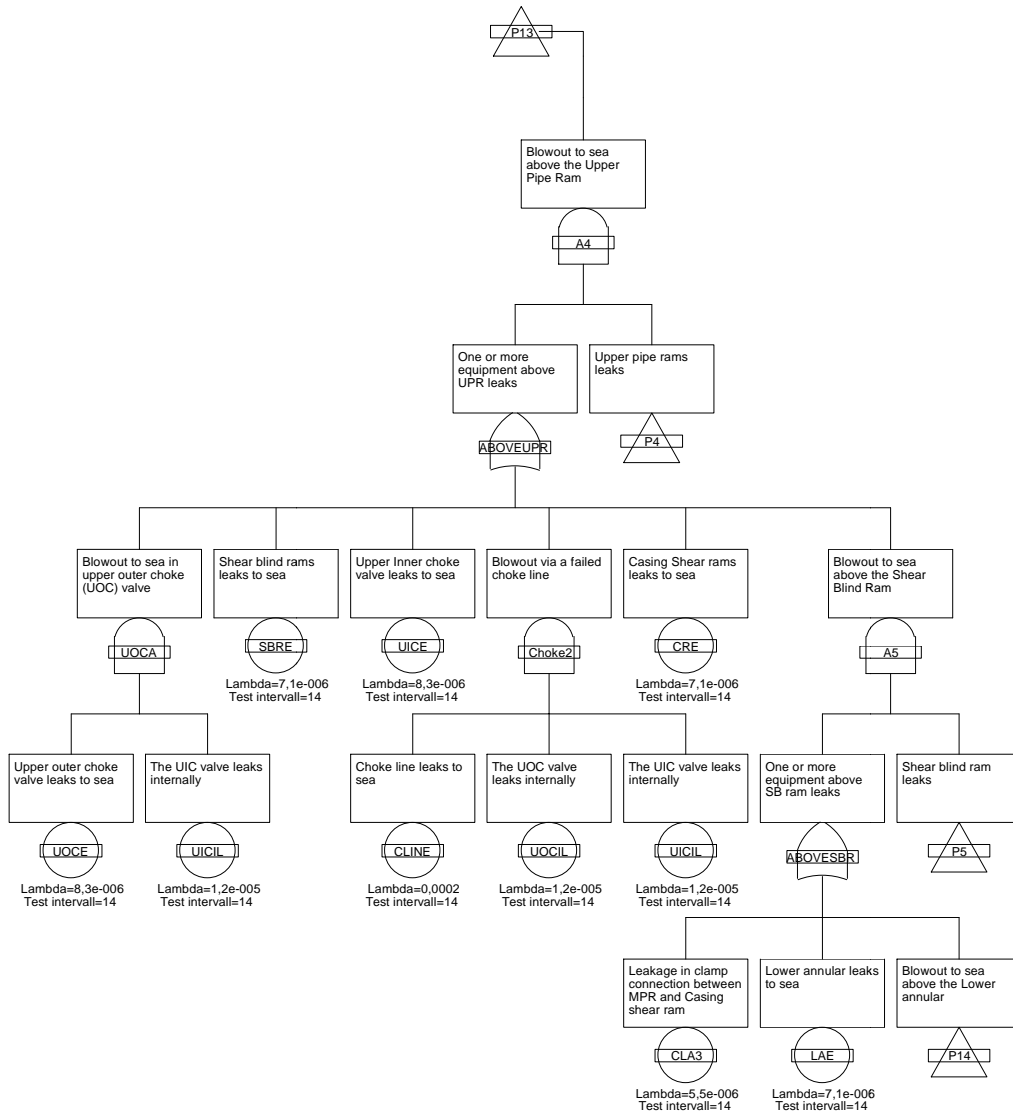
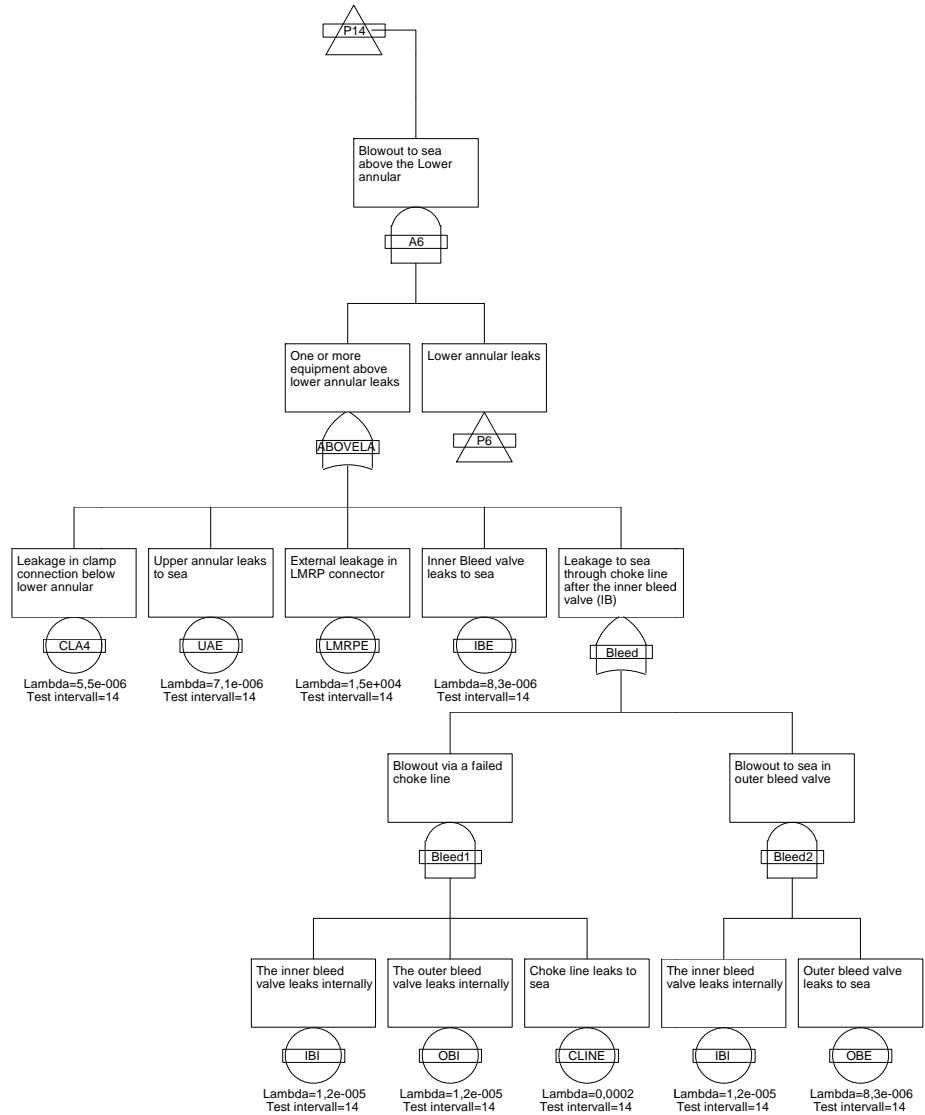
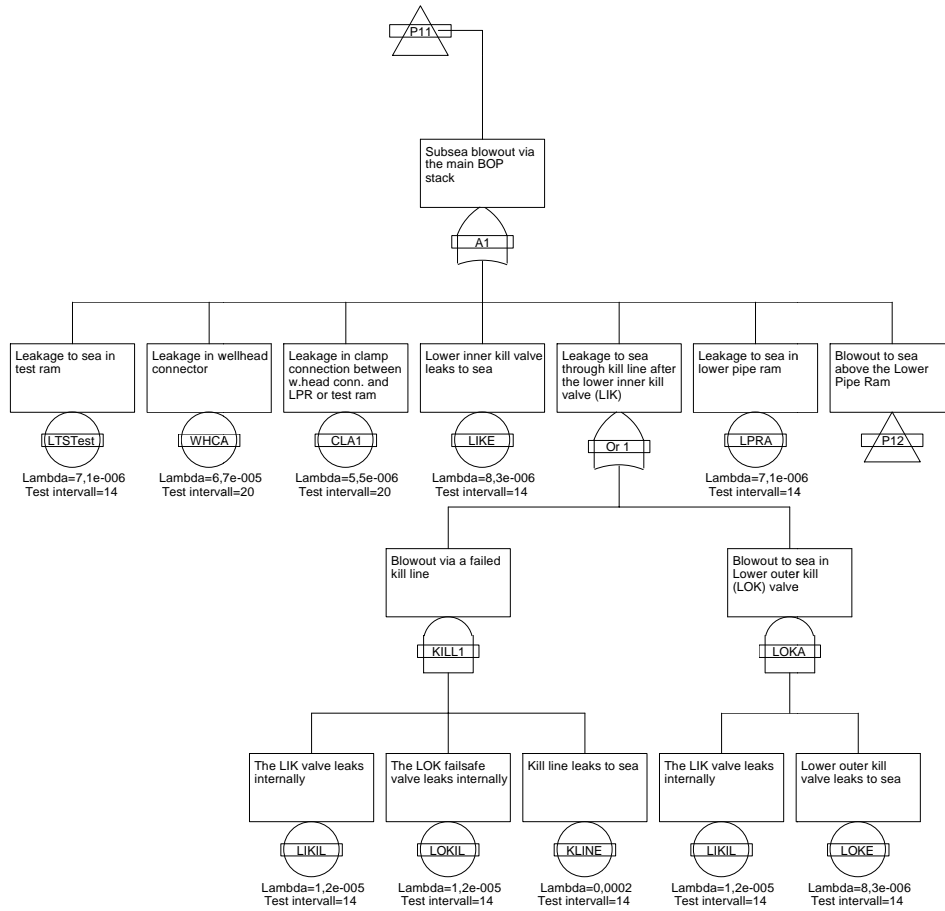
The fault tree utilized in the analyzes are presented on the following pages. The input data shown represents the Modern BOP with a drillpipe running through the BOP.
