HPHT 17TR8 Test Articles: Post-Test Characterization Following Pressure Burst Testing (Final)

*Examination of F22 Materials Following Plastic Deformation from Controlled
Pressure Testing*

Prepared for the U.S. Department of the Interior, Bureau of Safety and Environmental
Enforcement

April 30, 2018

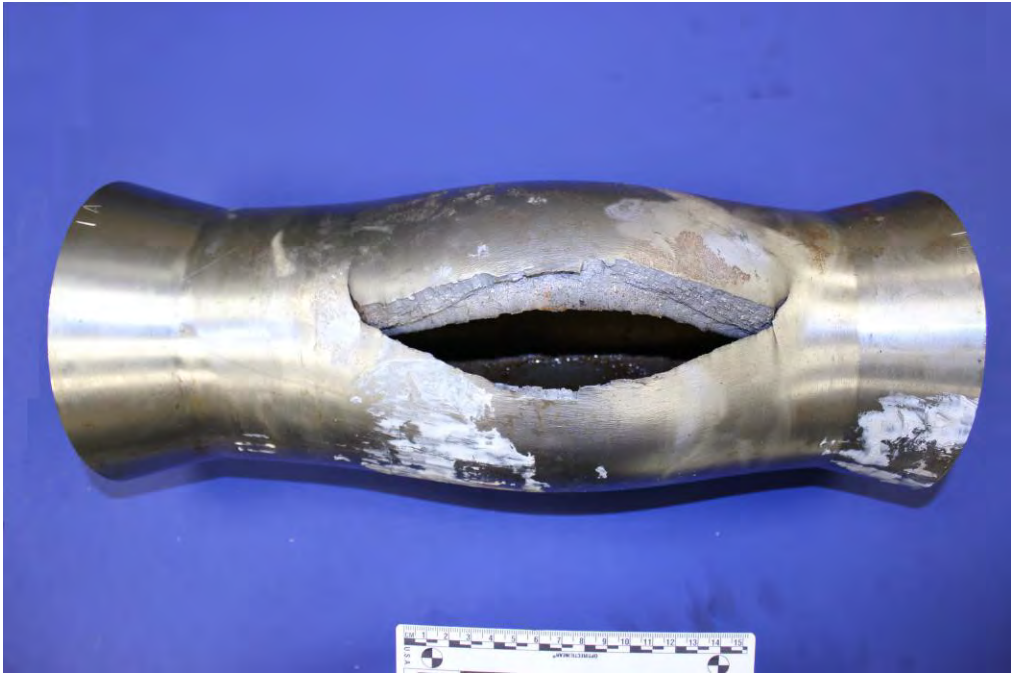
Figure 3: As Received Photograph – Sample 2 – Top View of Base Case at Burst (scale in mm)

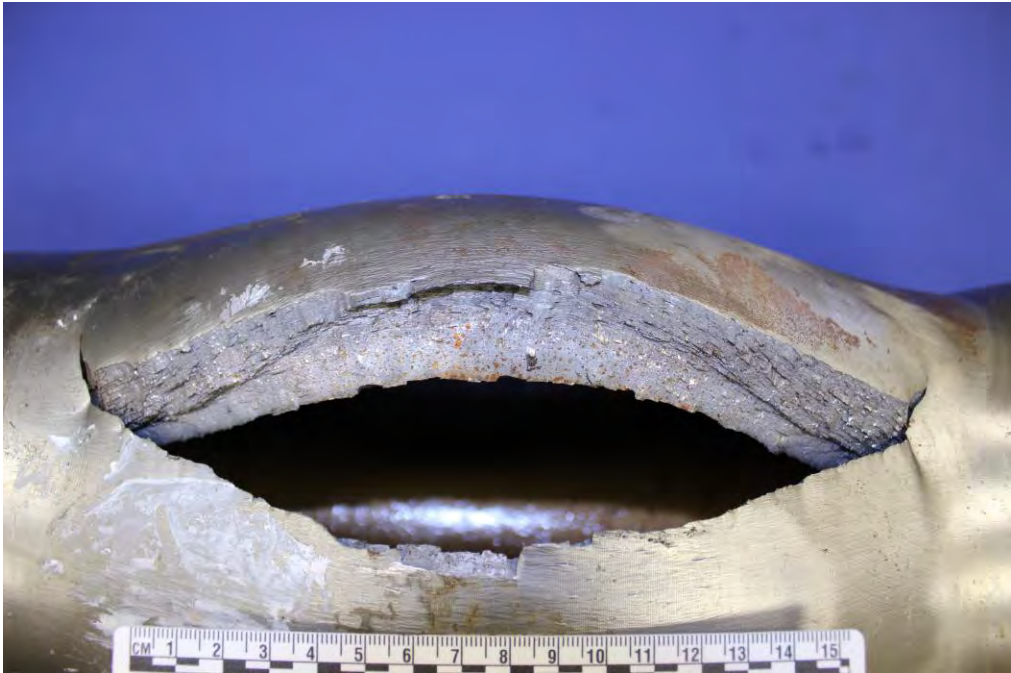
Figure 4: As Received Photograph – Sample 2 – Close-up View at Burst (scale in mm)

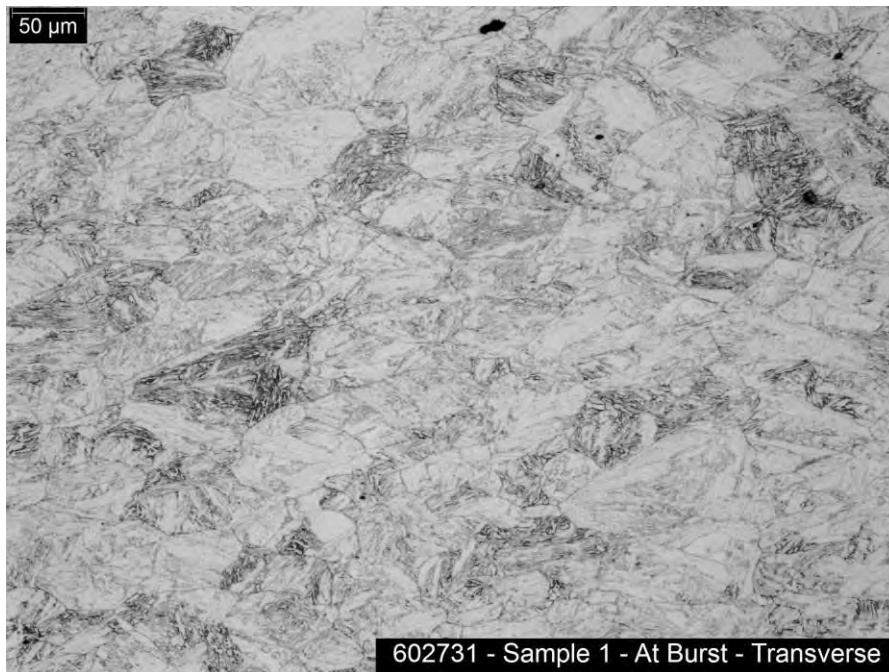
Figure 22: Sample 1 – Micro photograph of Transverse cross-section at Burst, Grain Size No. 7
