Damage and Critical Analysis of Accidents to Assist in Avoiding Accidents on Offshore Wind Farms on the OCS

May 2010

Project No. 633, Contract M09PC00015

This document is the Report on Damage and Critical Review of Accidents: documentation of significant damages relevant to wind farms for which appropriate information is available together with analyses of the causes when available.

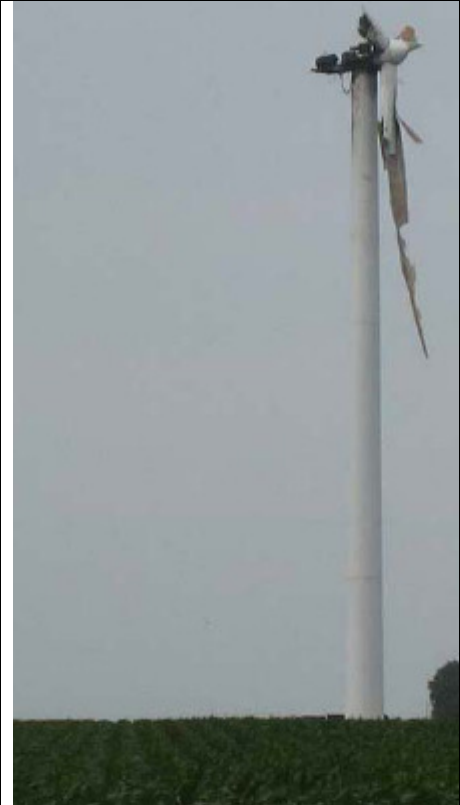
Environmental – Oilspill down the tower from gearbox of wind turbine (Spain)

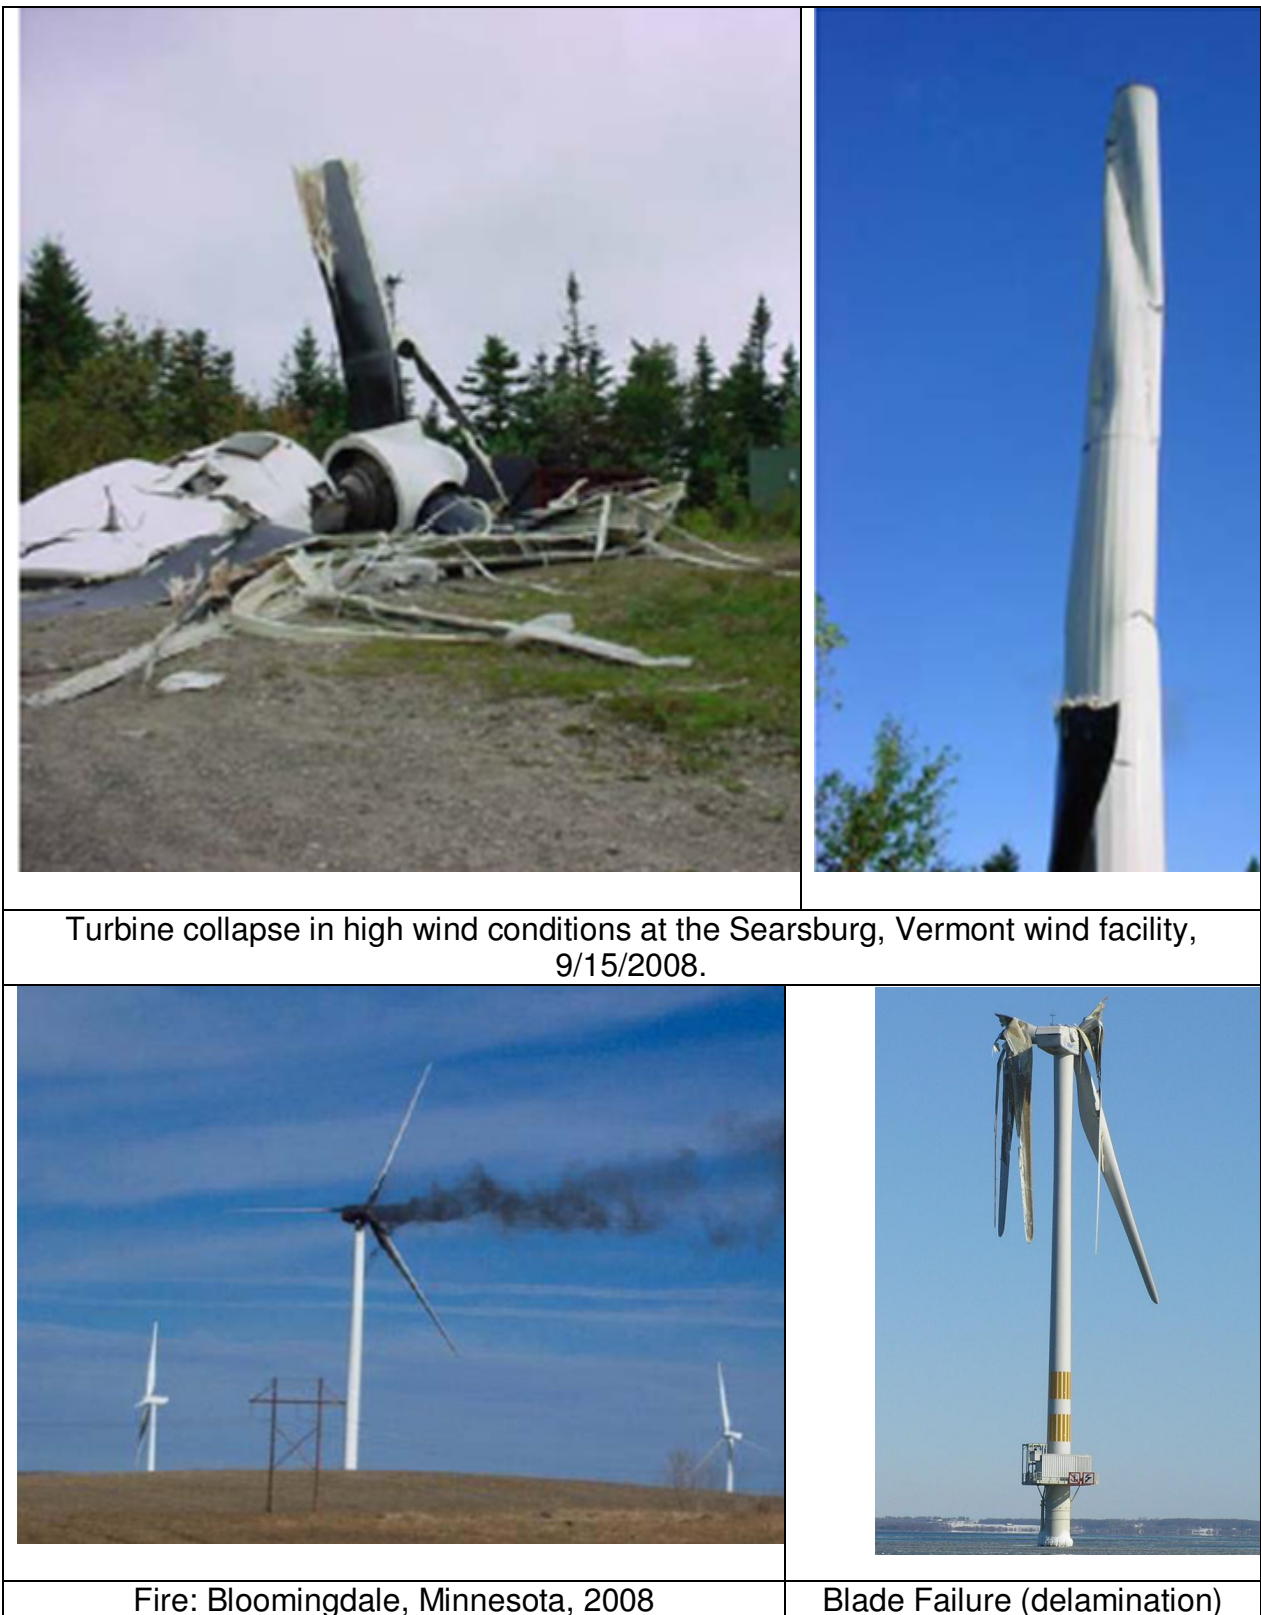
Figure 1: Illustration of Categories of Accidents

Lightning Strike

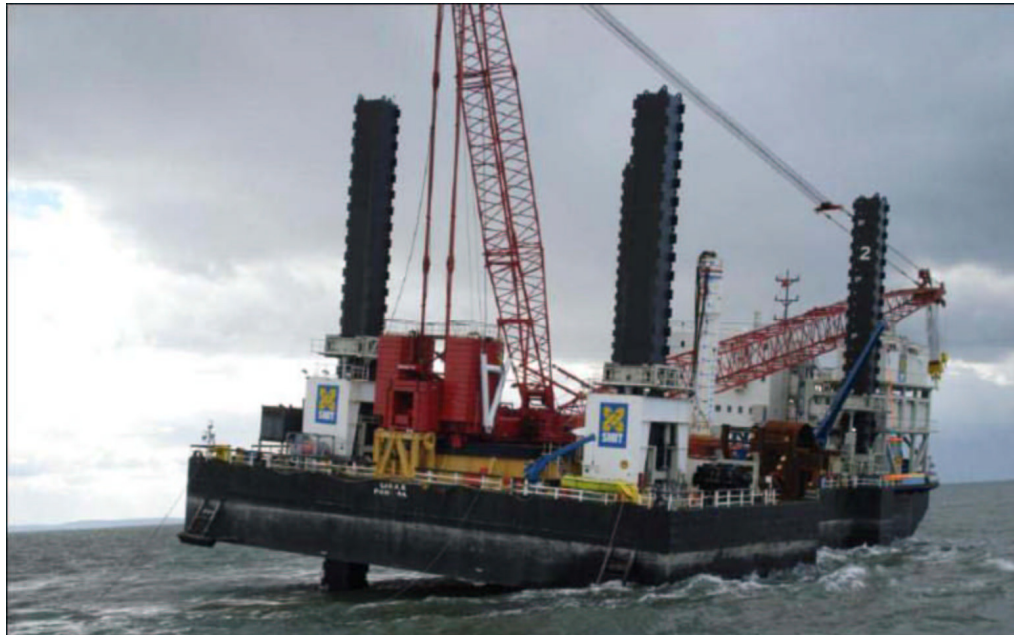
Figure 2: Smit Lisa at Robin Rigg

Name	Summary	Location	Year
9	Smit Lisa	Punch-through: hull dropped	Robin Rigg	2007

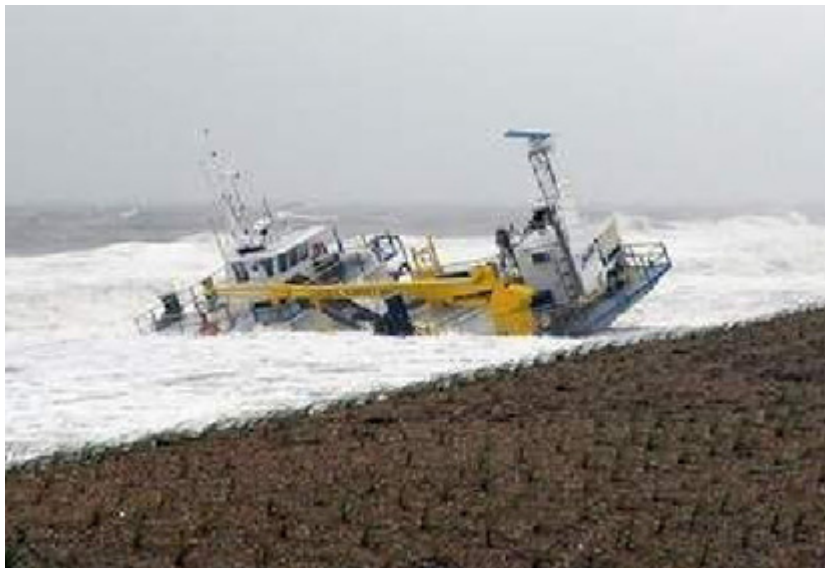
Figure 3: Russell W. Petersen Offshore Delaware

Name	Summary	Location	Year
12	Russell W. Peterson	Wrecked, 1 fatality	Delaware	2008

A Coast Guard rescue swimmer found one of the crewmembers of the Russell W. Peterson dead, possibly crushed by heavy objects, in the galley, when he boarded the ship during the May 12 nor'easter.

During the storm, it's surmised that the liftboat had its three legs, or spuds, anchored to the sand, until one broke. "That was what came over the mayday call from the captain," McLaughlin said. The leg at the rear of the boat was the one with the apparent problem. In order to make the trip from the Gulf Coast up the intracoastal waterway and get under bridges, the owners cut the legs from 105 feet to 70 feet. McLaughlin would not comment whether shortening the legs contributed to the apparent failure of one. The boat, built in Louisiana 25 years ago, was christened in Wilmington on March 29, and arrived at the Lewes City Dock March 31.

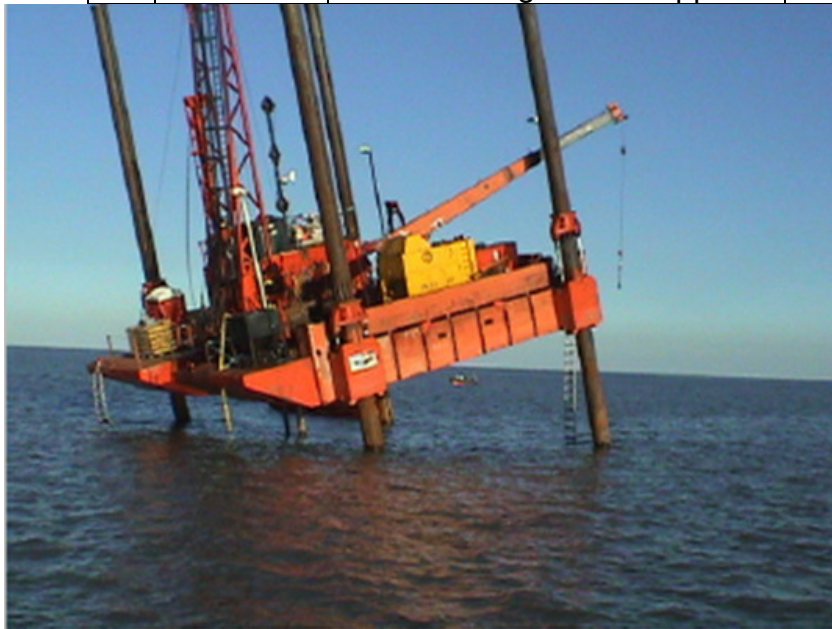
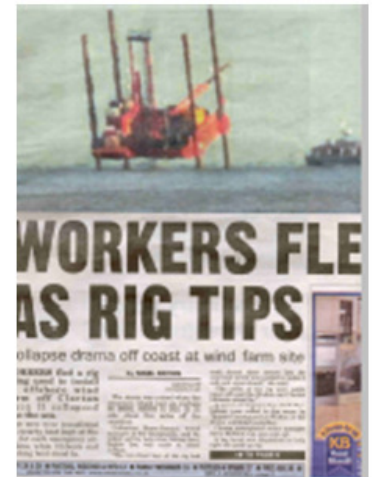
Figure 5: Skate II at Gunfleet

Name	Summary	Location	Year
3	Skate II	Punch-through: hull dropped	Gunfleet	2003

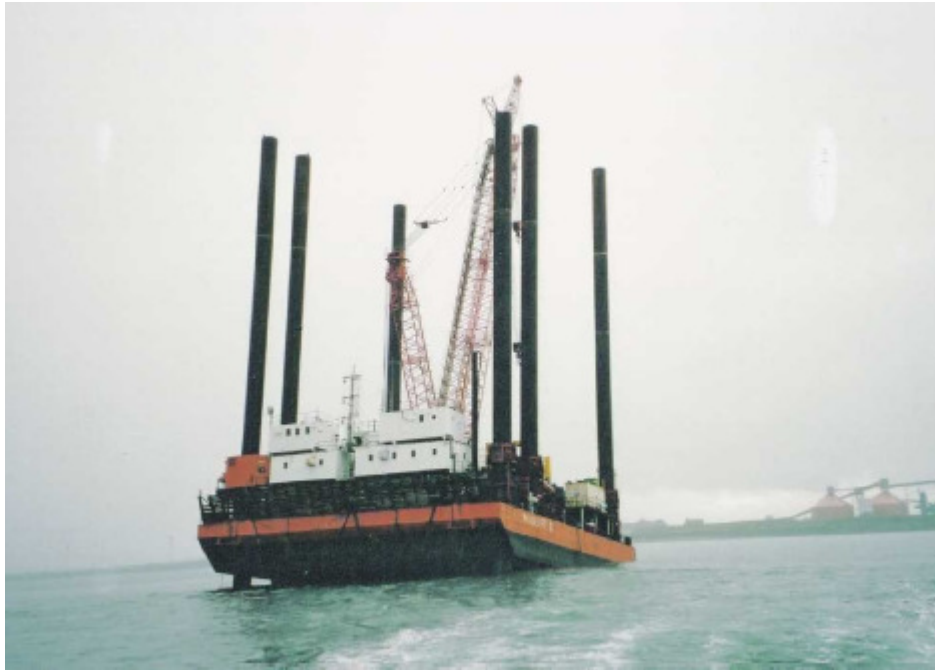
Figure 6: Wijslift 6 at Blyth

Name	Summary	Location	Year
2	Wijslift 6	Hull dropped	Blyth	2000

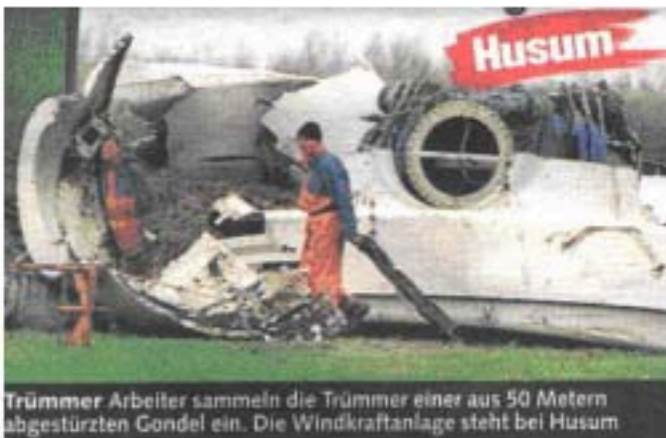
20020128.1.bmp

Trümmer Arbeiter sammeln die Trümmer einer aus 50 Metern
abgestürzten Gondel ein. Die Windkraftanlage steht bei Husum

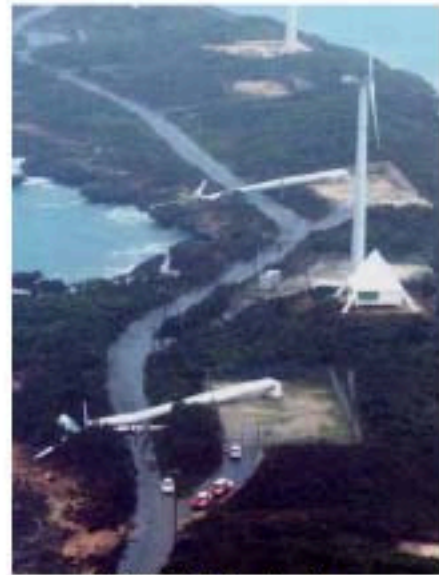
20030911.1a.bmp

Miyako region – All 7 turbines failed in typhoon Maemi(2003) (Gust 74.1 m/s)

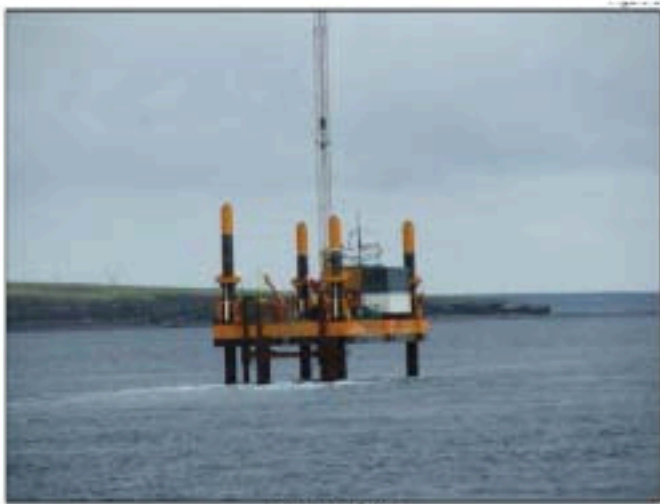
20061007.1.bmp

Jack up barge Octopus

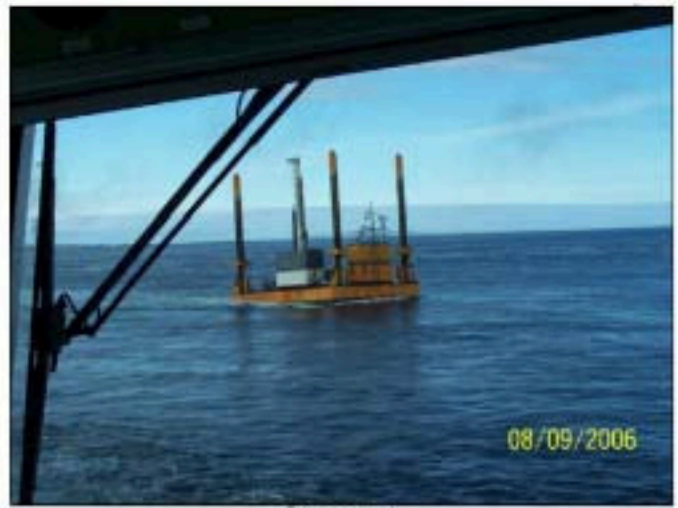
20069999.4.bmp

Octopus aground

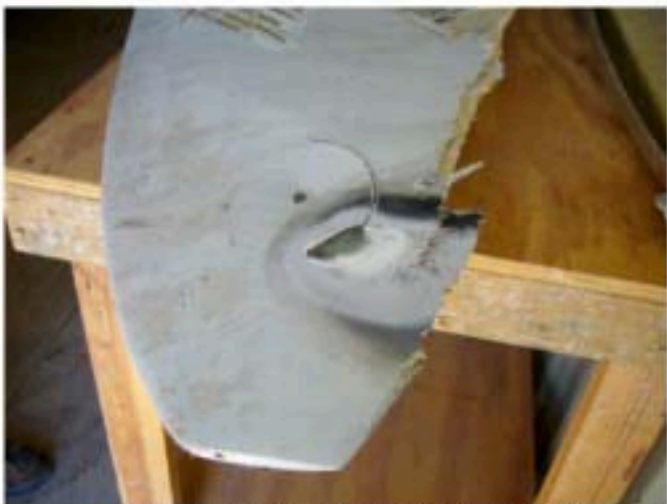
Figure 1: Characteristic lightning signature to Made tip

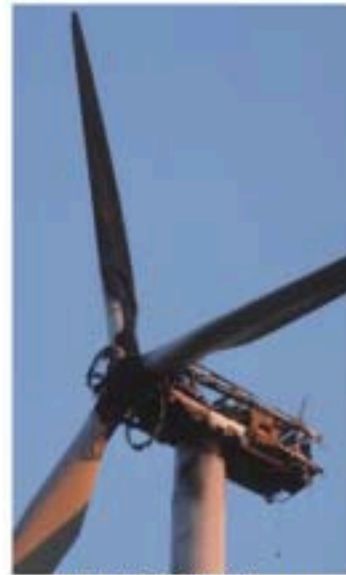
99999999.3b.bmp

Figure 3: Removal of damaged blade root by crane

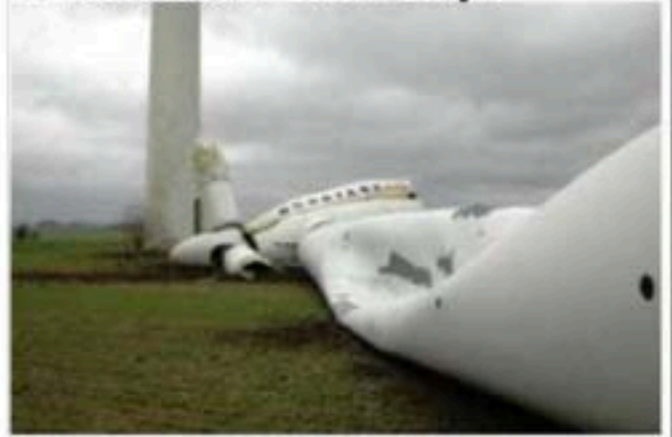
99999999.47.bmp

WTG accident – Run-away:

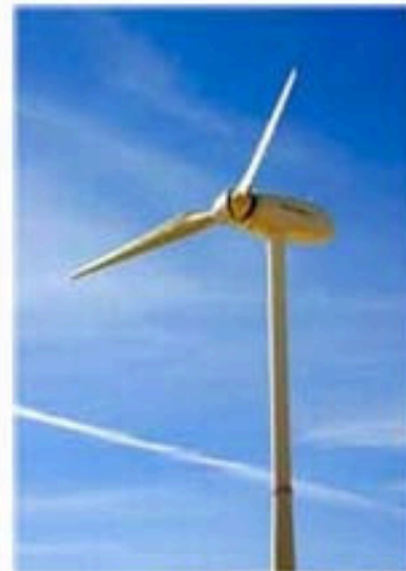
April 20, 2002: Fire
 VESTAS 1.5 MW
 Total height: 108 m
 Year of construction: 2000
 Location: Bad Wünnenberg-Heeren near Paderborn
 C20020420.1.bmp

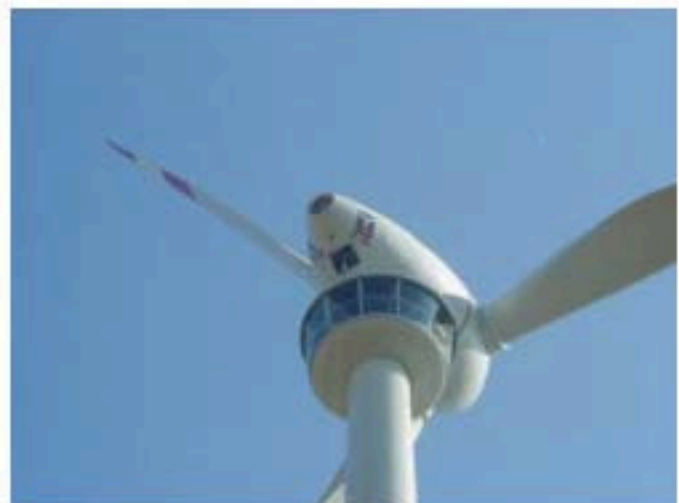
August 4, 2002: Fire
 VESTAS V80, 2 MW
 Year of construction: 2002
 Location: Katzenberg near Meißen
 C20020804.1.bmp

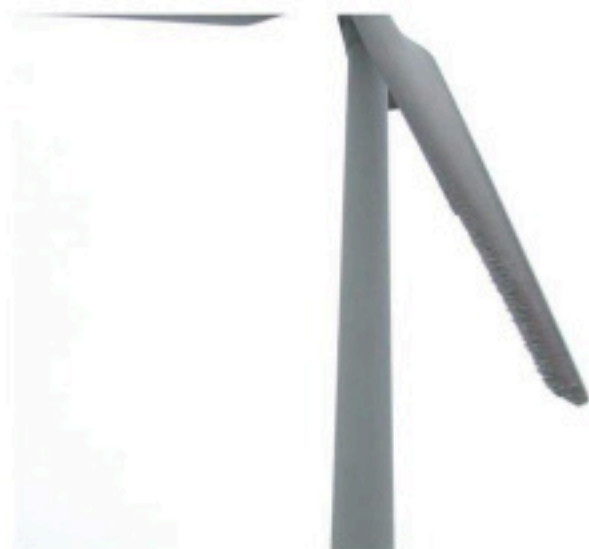
C20021115.1.jpg

Spezialzelle bringen am Freitag die Turbinen für eine Windkraftanlage auf einer Straße zwischen Moorfeld und Bad Moorfeld. Ein Lastwagen wie mit der 16 Tonnen schweren Säule vor der Fortfahrt abgekommen. Bei dem Unfall entstanden Schäden von rund 200.000 Euro.
